12.5 Late Presentation of Peri-implant Mucositis Requiring Soft-Tissue Augmentation and Esthetic Crown Lengthening at Implant Site 11

E. Lorenzana, J. Gillespie

The present case demonstrates the treatment of peri-implant mucositis caused by retained cement on a single-tooth implant-supported crown, followed by periodontal plastic surgery procedures and the provision of a new restoration to recreate the desired esthetic outcome.

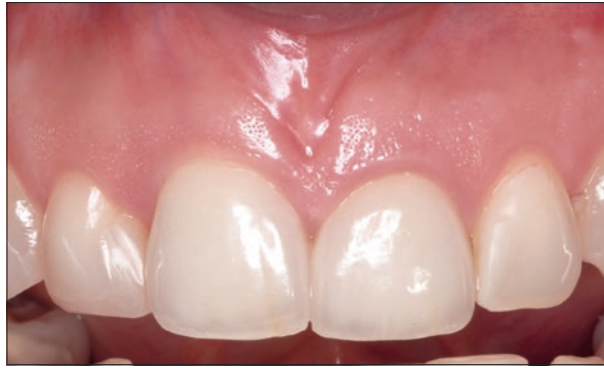
Figs 2 and 3 Result at 14 months with corresponding radiograph, showing no retained cement.

Following uneventful healing, the restorative process was completed with a customized zirconia abutment and cement-retained metal-ceramic crown (Maxcem, Kerr Dental). The result is pictured 14 months after surgery (Fig 2). A radiograph taken at the 14-month appointment revealed no significant findings, especially no visible retained cement at the crown margins (Fig 3).

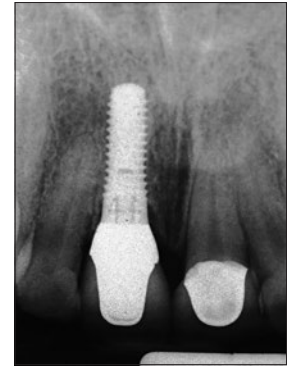
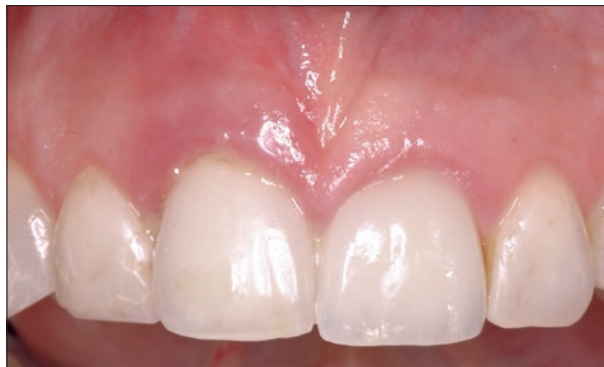
Figs 4 and 5 Clinical photograph and periapical radiograph four years later demonstrating peri-implant inflammation and retained film of cement on the distal aspect of implant crown 11.

Four years later, the patient presented with mucosal swelling, bleeding on probing, suppuration, and discomfort associated with implant crown 11 (Fig 4). A new radiograph was revealed a thin film of a material suggestive of retained submucosal cement, but no apparent loss of supporting bone (Fig 5). Upon inquiry, the patient recalled the crown loosening a couple of years previously and seeing a different dentist to recement the crown. She was unable to recall which dentist recemented the crown, nor the type of cement utilized.

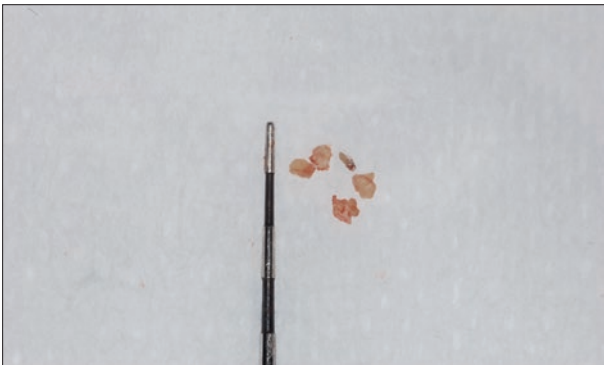
Fig 7 Removal of retained cement particles during the second SRP appointment four weeks later.

Inflammation and bleeding on probing persisted four weeks later. so additional scaling and root planing (SRP) was performed under anesthesia, resulting in the removal of additional cement particles (Fig 7).

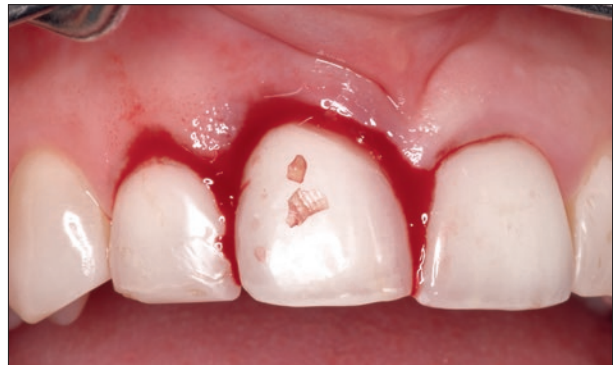
Fig 8 Clinical result following the non-surgical removal of cement fragments. There is 1 mm of exposure of the custom zirconia abutment.

Re-evaluation four weeks later resulted in resolution of the inflammation and discomfort, but at the same time the mucosal margin had receded, exposing 1 mm of the implant abutment (Fig 8). Although the patient was happy to no longer be in pain, she was not satisfied with the esthetics of the restoration as a result of treatment and requested help in correcting the situation.

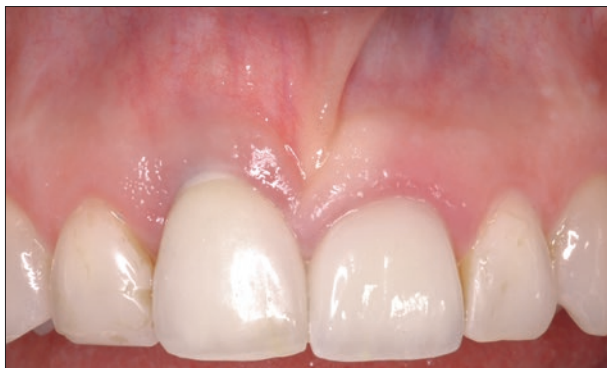
Fig 9 Implant 11 with new acrylic provisional restoration.

The treating dentist (JG) removed the implant abutment and crown and placed a modified PEEK RN synOcta Temporary Meso abutment (Institut Straumann AG) and a new cement retained bis-GMA provisional (Integrity; Kerr Dental, Brea, CA, USA), secured with Temp Bond (Kerr Dental) that would position the cement line at or near tissue level and allow for simpler removal and recontouring of the crown during later surgical procedures (Fig 9).

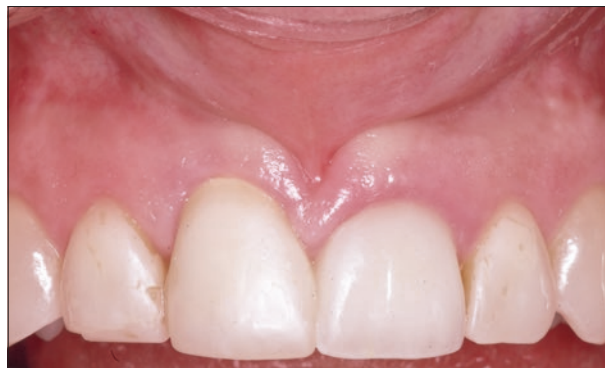
Fig 10 Illustration of proposed surgical and restorative plan.

The periodontal surgical plan included an autologous connective-tissue graft at site 11 to thicken and coronally reposition the mucosal margin, as well as crown lengthening to apically reposition the tissue at site 21, followed by new restorations at 11 and 21 (Fig 10).

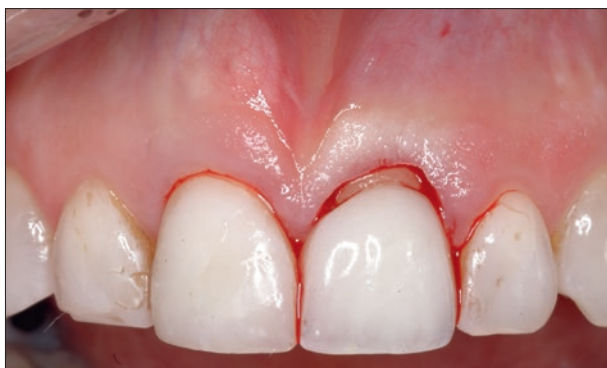
Fig 19 The probe demonstrates proper supracrestal gingival attachment (biologic width).

The gingivectomy was completed with an internally beveled incision and the supracrestal gingival attachment confirmed prior to releasing the patient for immediate provisionalization (Figs 18 and 19)

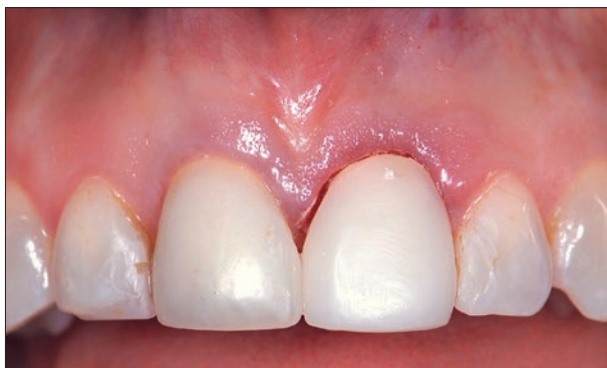
Fig 21 Two weeks after the gingivectomy.

Two weeks after the gingivectomy the desired symmetry of the gingival margin was accomplished (Fig 21).

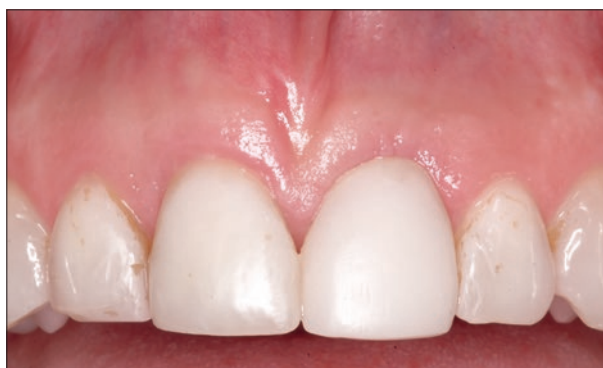
Figs 22 and 23 Delivery of the final restorations, with periapical radiograph confirming the absence of retained subgingival and submucosal cement.

Six months later, the final lithium disilicate restorations (Emax, Amherst, NY, USA) were delivered via careful cementation (Maxcem; Kerr Dental) using a customized zirconia abutment, raising the cement lines to an accessible position. A periapical radiograph was taken to confirm that no residual cement was present subgingivally or submucosally (Figs 22 and 23).

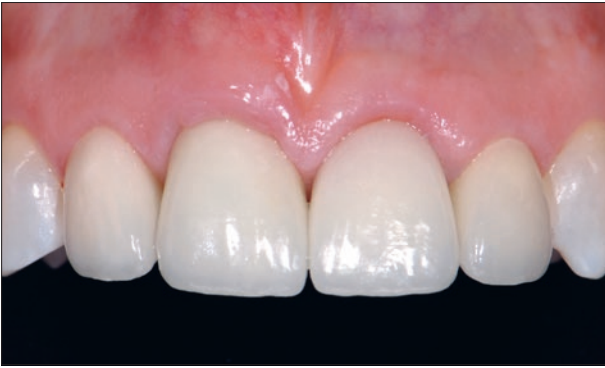
Fig 24 Two months after delivery, the patient was concerned with the space between 11 and 21.

Two months later, the patient returned for a consultation because she was dissatisfied with the blunted interdental papilla between crown 11 and tooth 21 (Fig 24). The patient was reassured that the crown contours and distance between the contact point and the interdental bone were ideal for complete papilla fill (< 5 mm) and that it was only a matter of time before the papilla would fill the space (Tarnow and coworkers 1992).

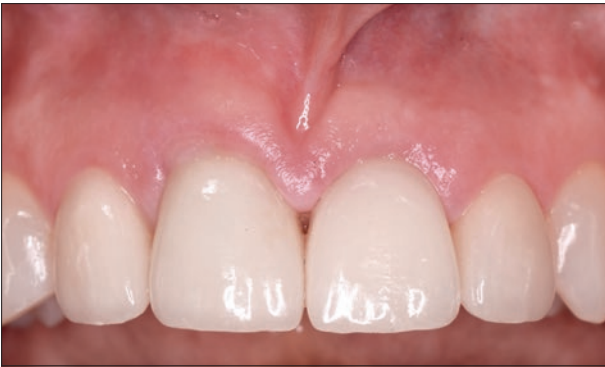
Fig 25 Complete papillary fill-in at one year.

One year later, the interdental papilla had indeed completely filled the interdental space (Fig 25).

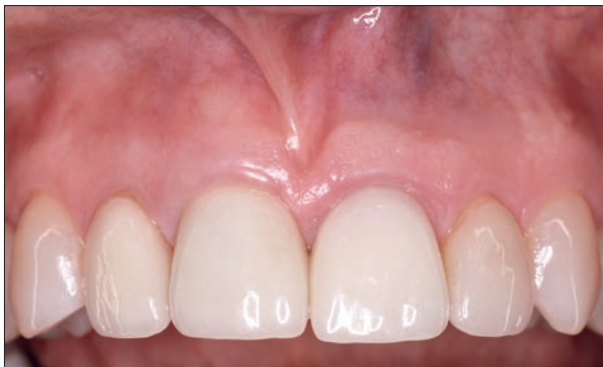
Fig 27 Retracted anterior view at six years (thirteen years after the original implant placement).

In addition, clinical photographs were obtained that documented the maturation and stability of the soft tissues and only minor scarring of the soft-tissue graft at site 11. Overall, the tissues had settled into the desired position, validating the long-term result of the reparative soft-tissue and restorative procedures, with the patient's smile displaying a pleasing, esthetic result (Figs 27 and 28).
