7.12 Replacement of a Missing Upper Left Central Incisor: Late Placement of an RC Bone Level Implant, CAD/CAM Zirconia Abutment

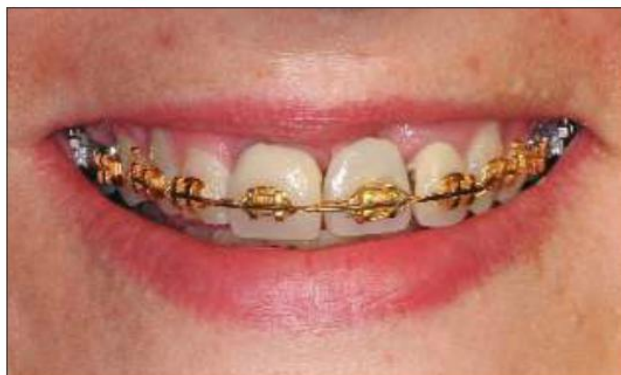
Fig 1 At full smile, the patient presented with a medium to high lip line, exposing the papillae throughout the anterior sextant, but with the upper lip obscuring the gingival margins of the central incisors.

A healthy 37-year-old female patient was referred for a consultation on the replacement of missing tooth 21 with an implant-supported restoration (Fig 1).

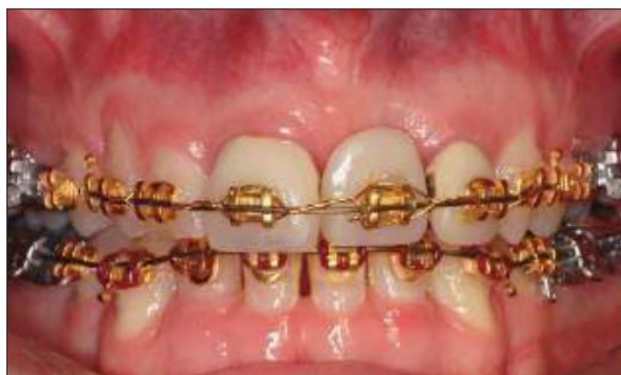
Fig 2 Retracted view of medium phenotype with inconsistent gingival margin positions and a buccal deficiency at the edentulous site.

A detailed examination of the teeth and periodontium at and around the edentulous space was performed to assess the esthetic risk of implant therapy. The retracted anterior view revealed a mutually protected occlusion, approximately 25% overbite, and a slight midline deviation between the maxillary and mandibular arches (Fig 2).

The observed gingival phenotype was medium-thick, with moderately scalloped papillae, relatively thick tissue, a broad zone of keratinized gingiva, as well as teeth and crowns with a squared-off appearance. The periodontal examination revealed a healthy periodontium with probing depths between 1 to 3 mm throughout the sextant. A buccal bone and soft-tissue volume deficiency was visible at site 21, and there existed a lack of harmonious gingival margin positions in the anterior segment 13 to 23. Measurements of teeth 13, 12 and 22 revealed a 1 : 1 height-to-width ratio, while 13 and 23 displayed an ideal 1.2 : 1 height-to-width ratio.

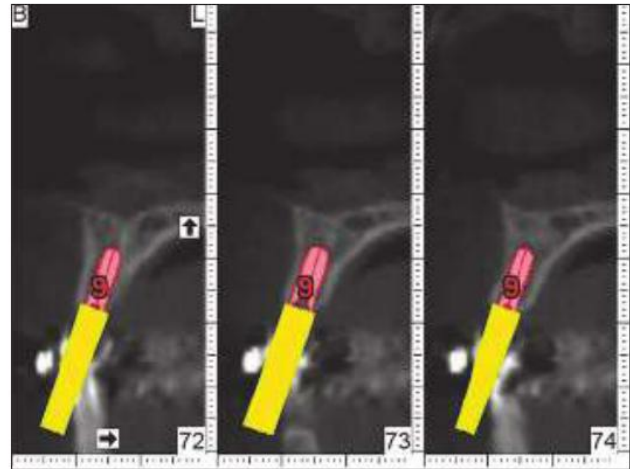
Fig 3 CBCT image with virtual implant placement showing adequate buccolingual bone volume for implant placement.

A cone-beam computed tomography (CBCT) scan was ordered and evaluated. No pathology was noted. The evaluation of the scan included virtual implant placement that revealed adequate bone for implant placement (Fig 3).

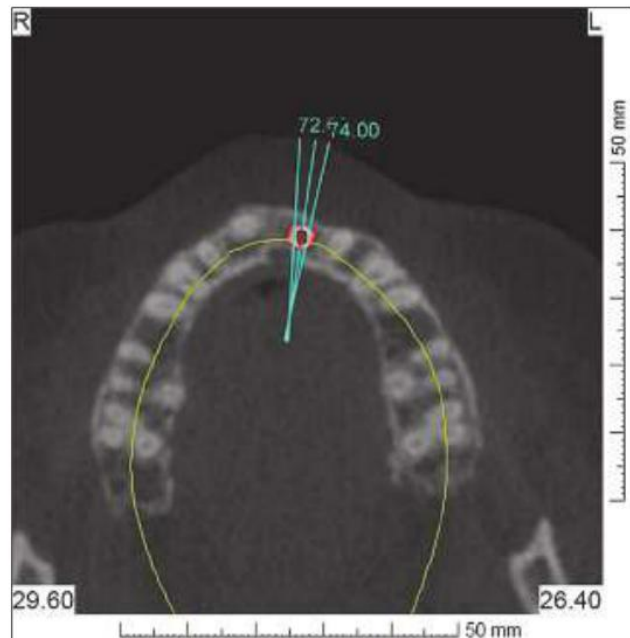
Fig 4 CBCT cross-sectional image revealed a slight but significant buccal deficiency at the edentulous site.

However, a cross-sectional view at the root level revealed a buccal deficiency that could have compromised the esthetic outcome of the case, as it relates to recreating the ideal root eminence and emergence profile (Fig 4). This confirmed what was observed clinically at the initial examination.

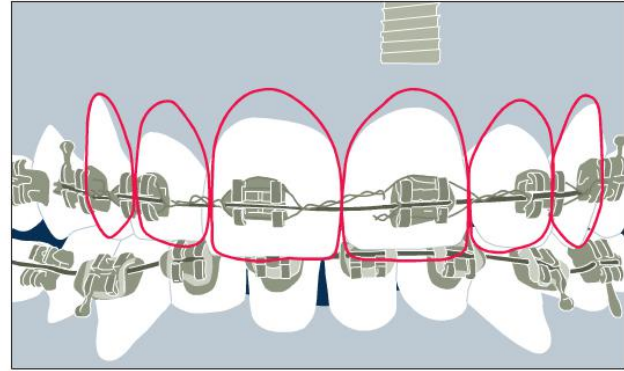
Fig 6 With the treatment illustration as a guide, the implant shoulder could be positioned 3 to 3.5 mm apical to the desired gingival margin.

It was discussed with the patient that crown lengthening would be critical to creating an acceptable esthetic outcome. Furthermore, it was considered essential that she understand that the desired final gingival margin position guides the apicocoronal positioning of the implant. The illustration shows the ideal apicocoronal implant position, allowing 3 to 3.5 mm of distance from the implant shoulder to the desired gingival margin (Fig 6).

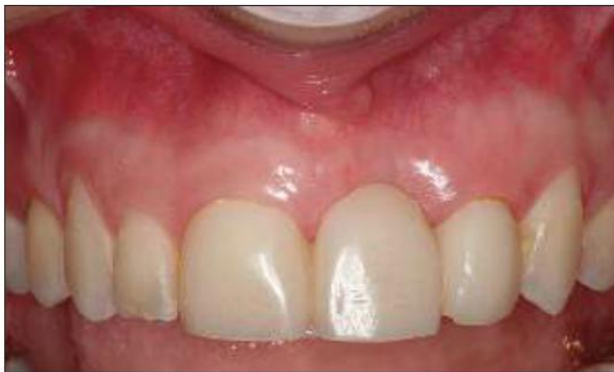
Fig 7 An acrylic FPD was placed as a provisional following removal of the orthodontic appliance. The pontic was fabricated to the desired final clinical dimensions.

With the treatment plan in place, the orthodontic appliances were removed and a fixed provisional was fabricated by the patient's prosthodontist. The pontic was made to reflect the desired dimensions of the final restoration in order to help guide the final implant position as well as the crown-lengthening procedures on teeth 12, 11, and 21 (Fig 7).

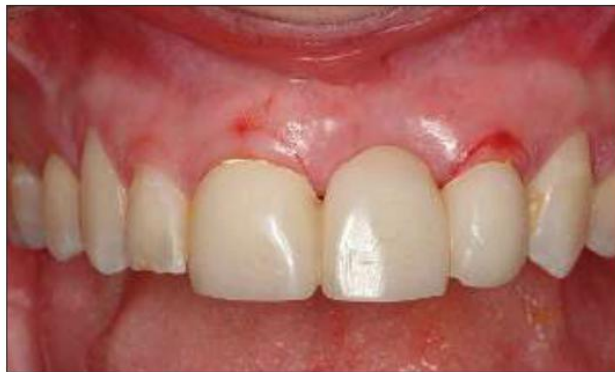
Fig 8 The desired gingival-margin positions were outlined.

The first step in the surgical procedure was to outline the proposed clinical crown height (Fig 8). The contours were designed to create symmetry throughout the anterior segment. The provisional was removed to allow visualization of the surgical site and completion of the incision (Fig 9). The occlusal view demonstrates the deficiency in buccal contour that could compromise the final esthetic result (Fig 10).

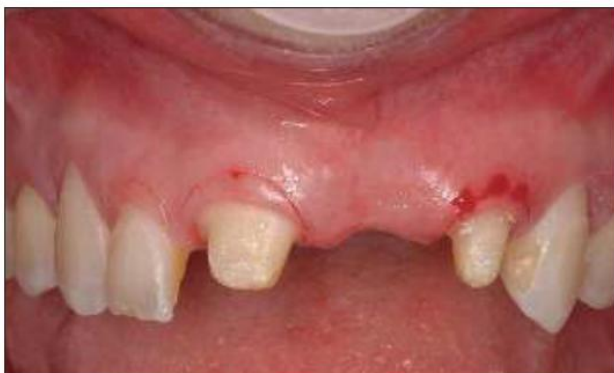
Fig 9 The provisional FPD was removed to allow completion of the incisions and flap elevation.

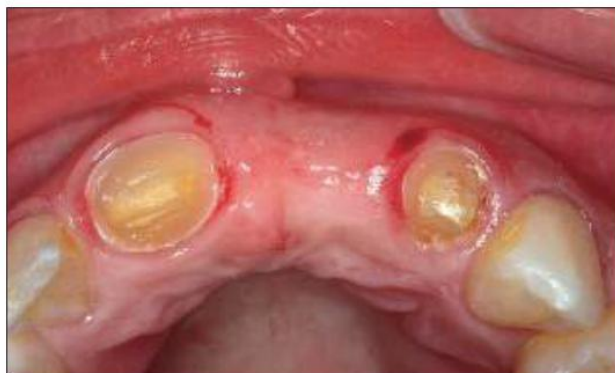
Fig 10 Occlusal view of the surgical site showing the deficient buccal contour.

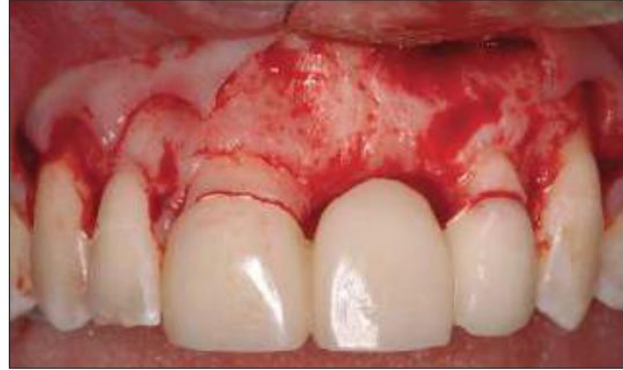
Fig 11 The provisional in place after flap reflection demonstrated an overabundance of bone, given the desired apicocoronal implant position.

Following flap reflection, the provisional was seated once more to properly evaluate the bone volume and position in relation to the desired implant shoulder position (Fig 11).

The overabundance of bone shown here would have complicated the ideal placement of the implant in relation to the desired emergence profile. 3 to 3.5 mm of space is needed to properly develop the necessary emergence profile. Crown lengthening was performed first on teeth 12, 11, and 22 using rotary and hand instrumentation (Fig 12).

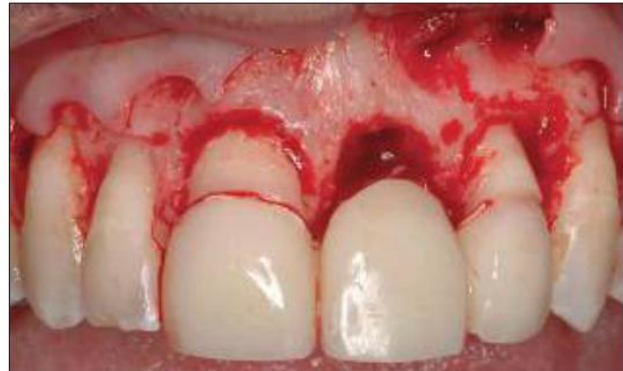
Fig 12 Crown lengthening was performed on teeth 12, 11 and 22. The osseous contour at site 21 mimics the contour of the natural dentition.

This created the ideal biologic width around the teeth. Osseous recontouring was then accomplished at site 21 to create space for the correct implant depth and mimic the biologic width in the rest of the anterior sextant. The resulting osseous contour not only allows for the proper apicocoronal implant shoulder placement, but also more accurately reflects the natural contours of the alveolar bone around the teeth. Note that the bone at the mesial aspect of teeth 11 and 12 was left intact in order to properly support the interdental papillae.

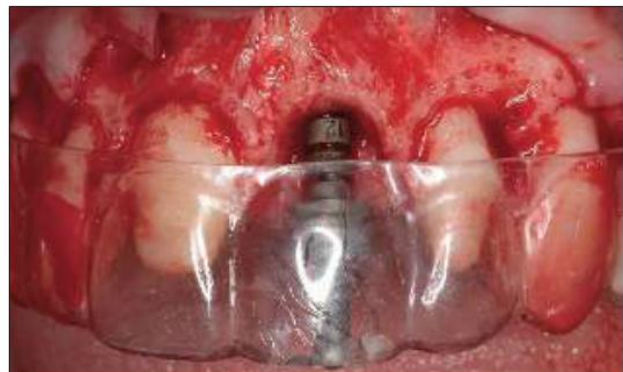
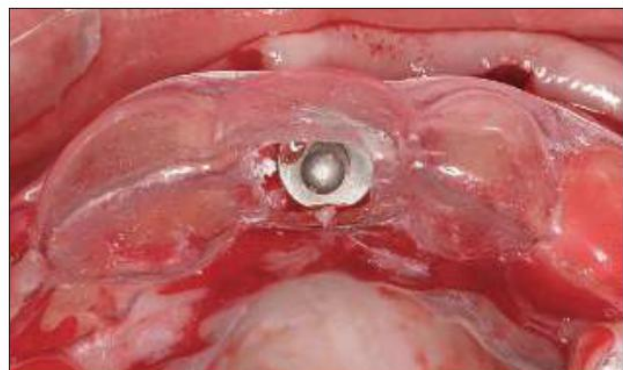
Fig 13 The vacuform template and 2.8-mm diameter depth gauge from the buccal aspect.

Fig 14 View of the vacuform template and 2.8-mm diameter depth gauge from the occlusal aspect.

To further facilitate ideal three-dimensional implant placement in accordance with the prosthodontic plan, a vacuform surgical template was utilized for site preparation (Figs 13 and 14).

In situations where significant modifications have to be made to the recipient site, a surgical guide provides a helpful reference point for correct fixture placement. The template provided guidance in both the orofacial and apicocoronal position, ensuring adequate space for development of the future emergence profile.

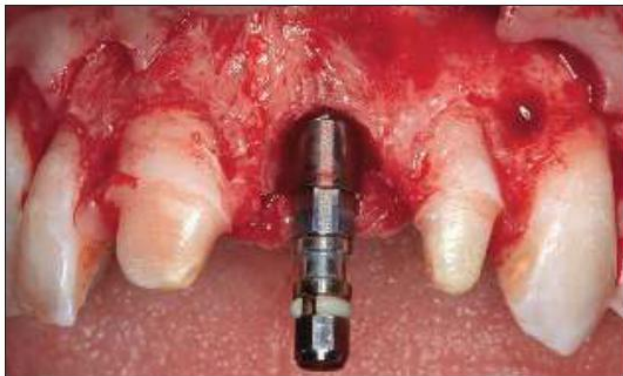
Fig 15 Bone Level implant in position.

Upon completion of site preparation, the implant (Bone Level implant, diameter 4.1 mm, length 12 mm, Regular CrossFit SLActive; Institut Straumann AG, Basel, Switzerland) was shown in its ideal three-dimensional position, in accordance with the restorative plan (Fig 15).

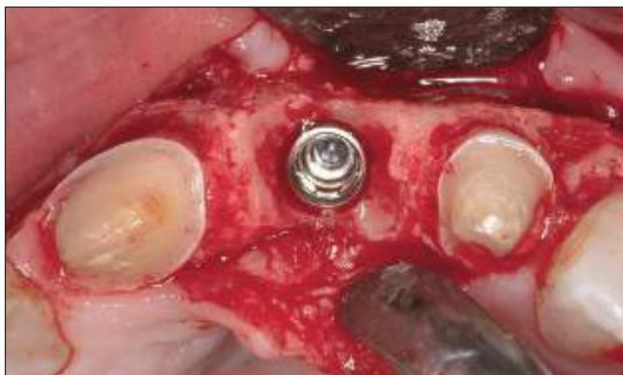
Fig 16 Occlusal view of the Bone Level implant. It is encased in native bone, yet a buccal defect remains.

The occlusal view of the final implant position showed the implant fully enveloped within the native bone (Fig 16).

However, a buccal defect remained, as previously observed in the CBCT scan. This defect could compromise the final esthetic result if not augmented to more closely resemble the contours of the natural dentition.

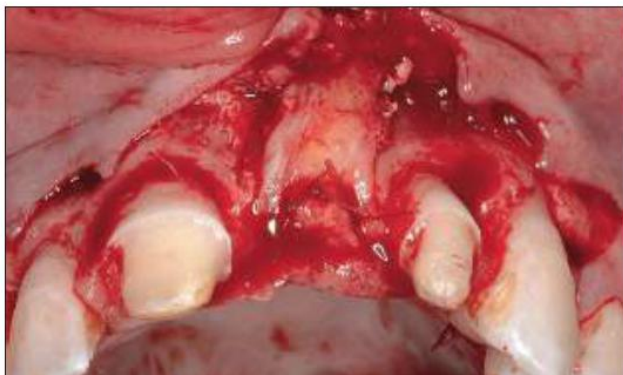
Fig 17 The buccal defect was augmented with deproteinized bovine bone mineral and a connective-tissue graft.

Following placement of a healing cap (Bone Level Regular CrossFit, height 2 mm; Institut Straumann AG), a xenograft derived from bovine hydroxyapatite (Bio-Oss, Geistlich, Wolhusen, Switzerland) was placed on the buccal aspect of the socket and covered with an autologous connective-tissue graft harvested with palatal periosteum using a single-incision palatal harvest technique (Lorenzana and Allen 2000) (Fig 17).

The tissue graft was secured with 5-0 chromic gut suture (Ethicon, Pittsburg, PA, USA) coronally and apically over the xenograft.

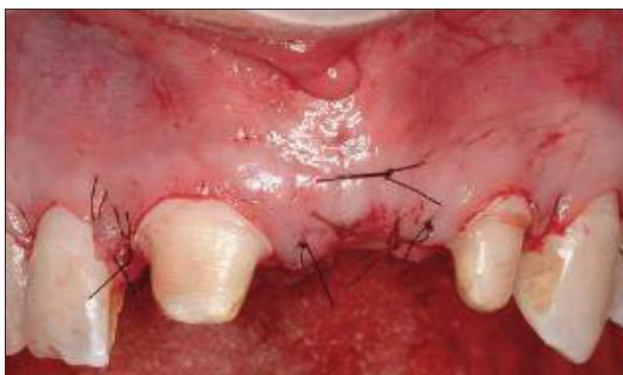
Fig 18 Tension-free primary closure was obtained with a horizontal mattress suture and single interrupted sutures.

Flap closure was accomplished using 6-0 nylon suture (Ethilon; Ethicon) (Fig 18). The flap was reapproximated and sutured first at the papillae, followed by a horizontal mattress suture to relieve the tension in the flap. Interrupted sutures were placed to then obtain primary closure of the flap over the implant.

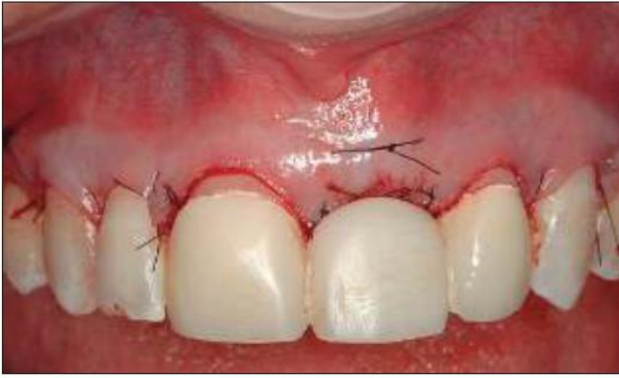
Fig 19 The provisional was adapted prior to cementation in order not to impinge upon the surgical site.

Prior to re-cementing the provisional, the pontic was relieved over the implant site so as not to impinge on the tissues (Fig 19). A periapical radiograph was taken to document the final implant position (Fig 20).

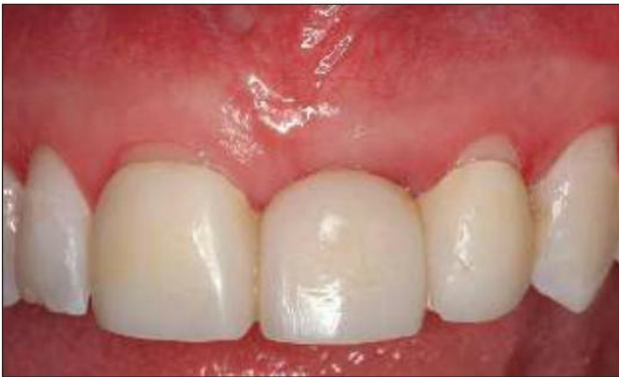
Fig 21 Healing at seven weeks. Re-entry procedures were initiated at this appointment.

The patient was seen two weeks after surgery for suture removal. Following an uneventful post-operative healing period of seven weeks, the patient was scheduled for re-entry (Fig 21).

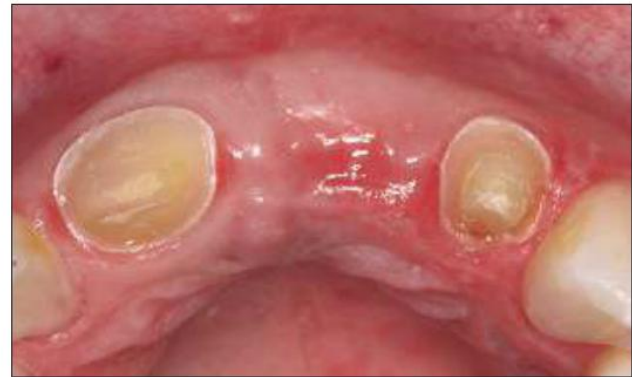
Fig 22 Following removal of the provisional, the occlusal view showed abundant soft-tissue volume and keratinized mucosa.

Due to the volume of tissue available at the implant site following augmentation, as well as the more than adequate amount of keratinized gingiva present, the implant was uncovered utilizing a tissue punch (Figs 22 and 23). The smaller healing cap was replaced with a longer healing cap to begin the development of the peri-implant soft-tissue profile. Healing was uneventful; four weeks later, the patient was referred to her prosthodontist for the initiation of restorative procedures.

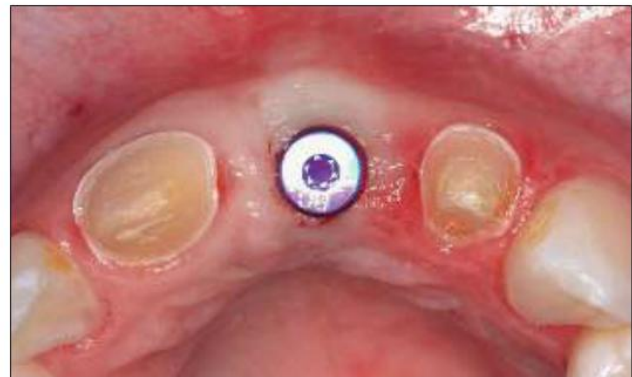
Fig 23 The uncovering was accomplished with a tissue punch. A longer healing cap was placed to allow access to the implant and initiate soft-tissue profile development.

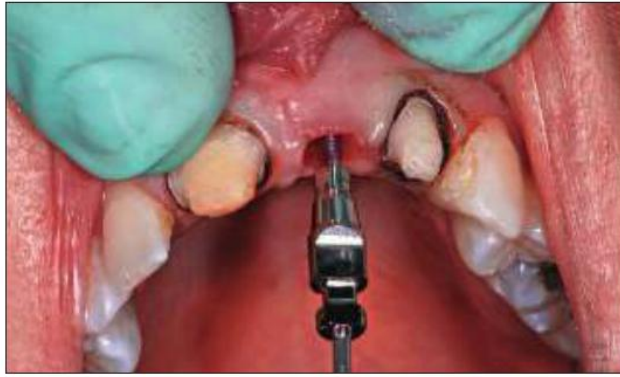
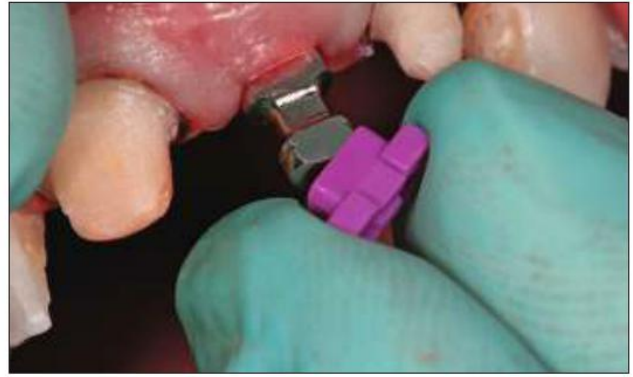
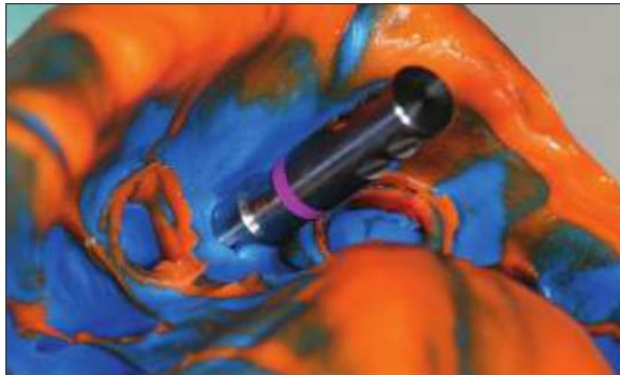
Fig 24 Delivery of the RC impression post.

Fig 25 Placement of the polymer impression cap on the impression post.

Fig 26 Following the removal of the impression post, it is placed onto the analog and placed back into the impression. The impression can now be poured to fabricate the master cast.

First, a fixture-level impression was taken along with the adjoining preparations by placing a Regular CrossFit (RC) impression post into the implant and tightening the guide screw with an SCS screwdriver (Fig 24). The polymer impression cap was then placed on the impression post and the impression taken (Fig 25). After the impression had set and been removed, the polymer cap remained in the impression. The impression post was removed, attached to a Regular CrossFit analog, and repositioned in the impression tray prior to pouring it in stone (Fig 26).

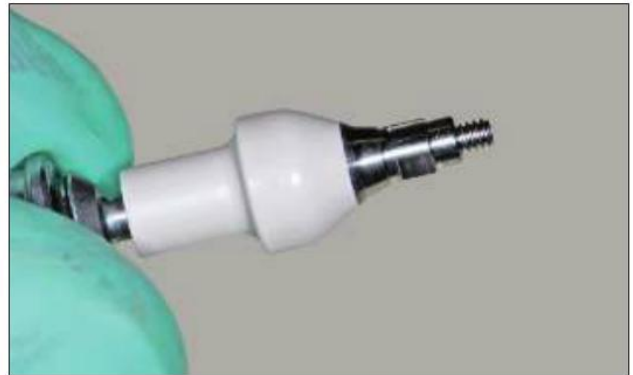
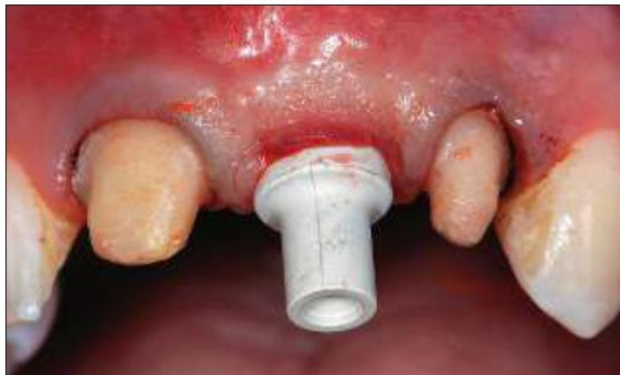
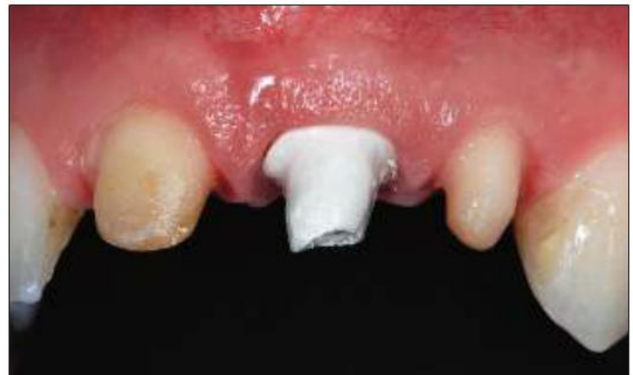
Fig 27 The Bone Level Regular CrossFit (RC) temporary abutment.

Fig 28 The unmodified temporary abutment is tried in and marked for reduction.

Fig 29 The modified temporary abutment fully seated.

At this point, the master cast was stored until the peri-implant tissues could be shaped and conditioned with the provisional restoration. Development of the emergence profile began with the modification of a Bone Level Regular CrossFit (RC) temporary abutment (Fig 27). After removal of the healing cap, the unmodified temporary abutment was seated and marked for reduction (Fig 28).

Following reduction, the temporary abutment was seated by turning the screw slowly, allowing time for the tissue to adjust to the pressure exerted by the abutment, until fully seated (Fig 29).

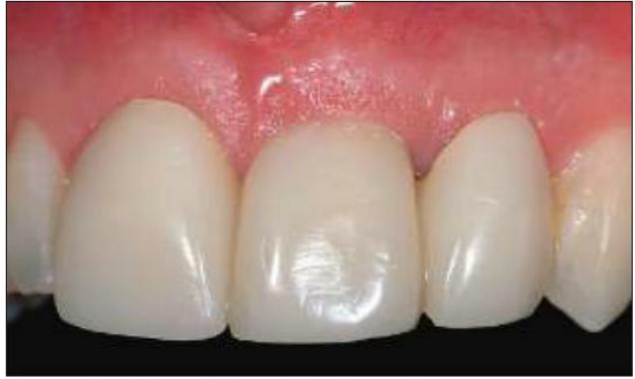
Fig 30 After delivery of the provisional restoration.

The patient wore the provisional for approximately four weeks until she was satisfied with the soft-tissue contours and overall esthetics (Fig 30). At this point, it was important to transfer the patient's soft-tissue contours to the master cast prior to sending the case to the laboratory. The provisional and temporary abutment were removed. The resulting emergence profile closely mimicked that of the contralateral tooth (Fig 31).

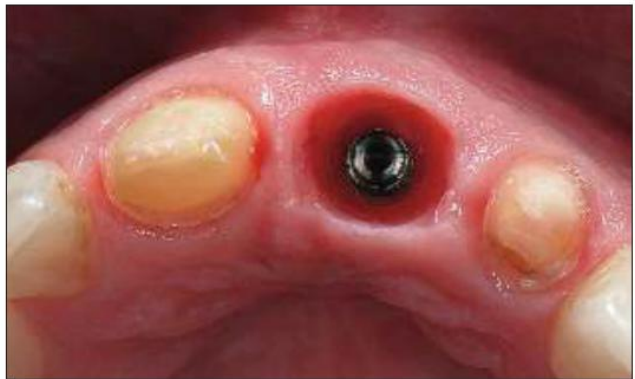
Fig 31 Occlusal view of the peri-implant tissue contours after development of the transition zone. Close similarity to the tissue contours around the contralateral central incisor.

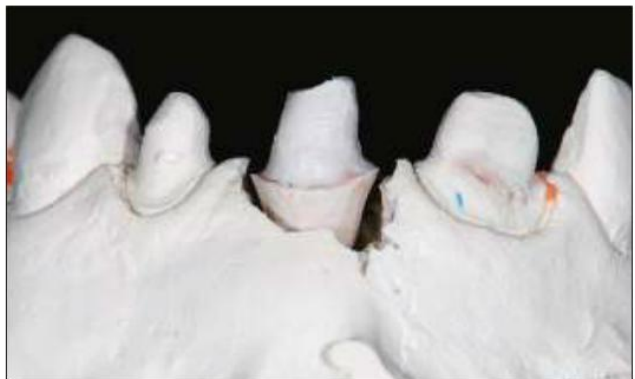
Fig 32 The provisional abutment seated on the master cast before custom soft-tissue modeling.

The original soft-tissue model was removed and the temporary abutment placed on the master cast (Fig 32).

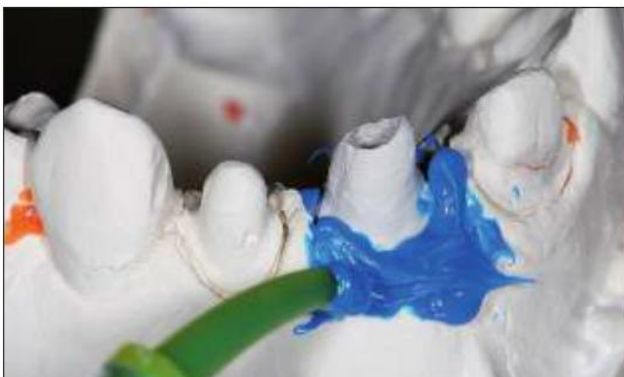
Fig 33 Impression material applied around the provisional abutment to record the transition zone onto the master cast.

Petroleum jelly was applied to the temporary abutment, and the new soft-tissue model was created by applying and forming impression material around the temporary abutment (Figs 33 and 34). The temporary abutment and provisional crown were then repositioned in the patient's mouth, and the case was sent to the laboratory.

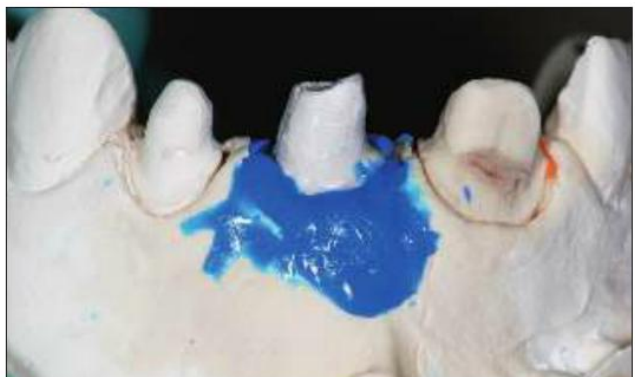
Fig 34 The custom soft-tissue model was now complete and the master cast ready to be delivered to the laboratory.

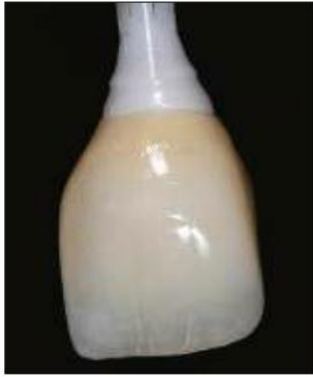
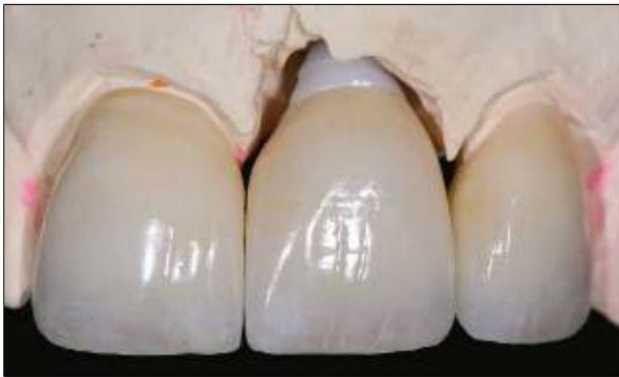
Fig 35 The definitive zirconia abutment and crown.

Fig 36 The definitive all-ceramic crowns on the master cast.

The laboratory fabricated a CAD/CAM zirconia abutment, made by first waxing up the abutment contours, then scanning the wax-up for milling of the final abutment. Once completed, an all-ceramic crown was made by building up ceramics over a zirconia core (Fig 35). Two additional crowns were fabricated for teeth 11 and 22 (Fig 36). The custom abutment and crown were returned for final delivery to the patient.

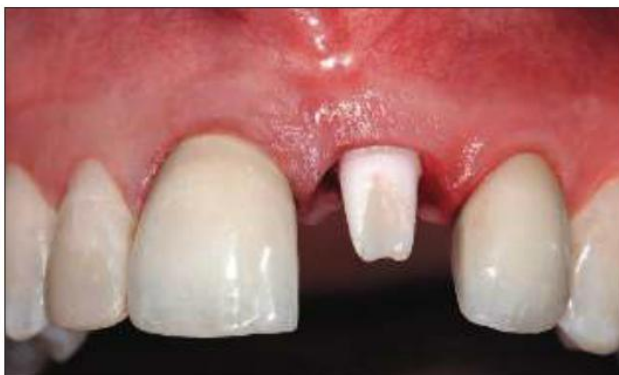
Fig 37 After insertion of the zirconia abutment, torqued to 35 N-cm and sealed with PTFE tape and composite.

At the delivery visit, the provisional restoration and abutment were removed. The implant and soft tissues were carefully cleaned and irrigated before delivery of the tooth-borne crowns and the custom abutment (Fig 37).

In addition, composite was bonded to tooth 12 in order to restore the contours to match those of tooth 22. Once the fit had been confirmed, the abutment was torqued to 35 N-cm, and the access opening sealed with PTFE tape and composite.

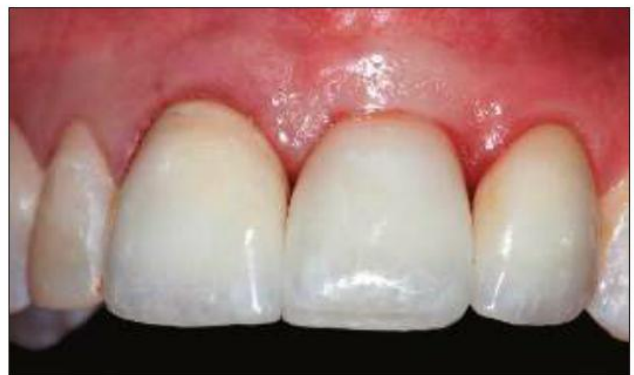
Fig 38 The final implant-supported restoration on the day of delivery.

The fit of the final restoration was carefully checked and the occlusion adjusted to a light contact as verified with shimstock prior to cementation. The restoration was cemented, and any excess was carefully removed following the final set (Fig 38). On the day of delivery, the shape, color, contour, and translucency of the restorations appeared to integrate harmoniously with the natural dentition. However, it was evident that following the restorative procedures, additional tissue healing and maturation was necessary prior to achieving the desired final esthetic result.

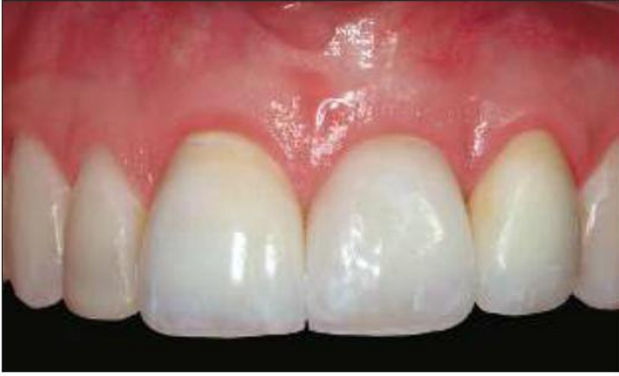
Fig 39 Retracted anterior view at one year after delivery. Symmetric gingival contours in harmony with the restorations across the anterior sextant.

The one-year photograph documents the final harmonious perio-prosthetic integration of the restorations and the gingival tissues that comprises a stable esthetic treatment outcome (Fig 39).

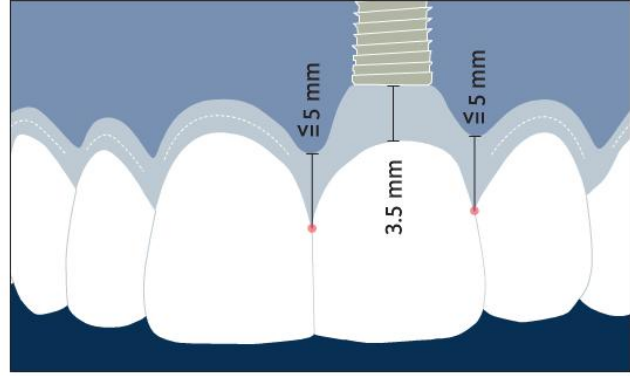
Fig 40 A stable soft-tissue level could be expected due to the ideal relationship between the bone crest, implant shoulder and contact points.

The contours of the marginal gingiva were symmetrical throughout the anterior sextant and in concert with the restorative contours of the restorations and natural dentition. The papillae completely filled the interdental spaces, a testament to the pre-operative planning of the apicocoronal implant position and surgical execution of the necessary osseous recontouring (Fig 40).

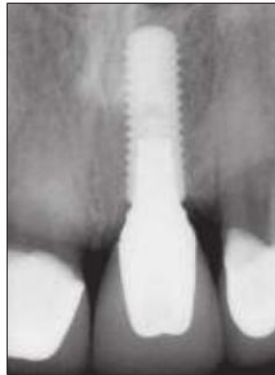
Fig 41 Periapical radiograph at one year.

The one-year postoperative radiograph demonstrated stable bone levels around the implant, with the appropriate interdental bone position in relation to the interdental contacts that supported the papillae at the mesial and distal aspects of the implant fixture (Fig 41).

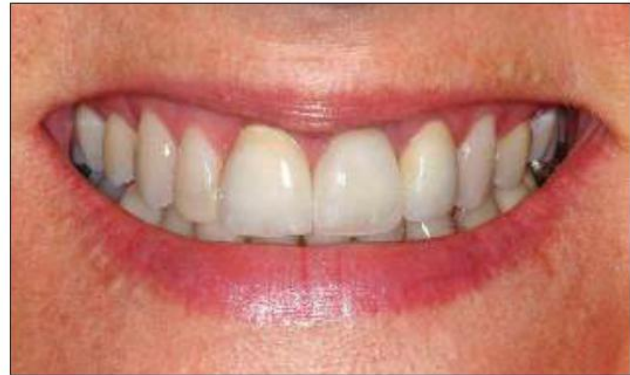
Fig 42 Full smile at one year after delivery, demonstrating a stable, pleasing esthetic result.

Finally, the one-year smile reflected the realization of the patient's vision and her satisfaction with the final esthetic result (Fig 42).
