ITI Treatment Guide

Implant Therapy
in the Esthetic Zone
Current Treatment Modalities
and Materials
for Single-tooth Replacements

7.1 Replacement of a Failing Upper Left Central Incisor: Immediate Placement of an RC Bone Level Implant and Provisionalization

E. R. Lorenzana, J. Gillespie

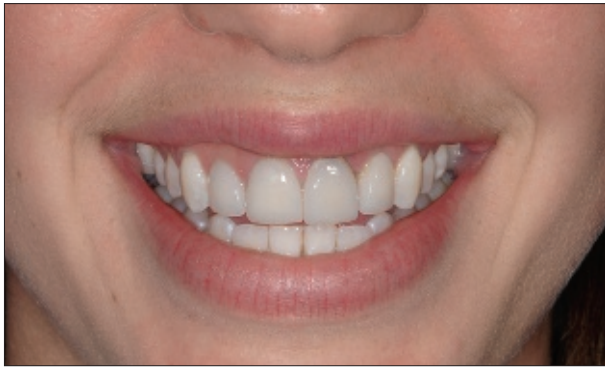
Fig 1 The patient presented with a medium to high lip line when smiling, exposing the papillae throughout the anterior sextant, but with the upper lip obscuring the gingival margins of the central incisors.

The analysis of her smile revealed a medium to high symmetrical smile line and a slightly discolored tooth 21 (Fig 1).

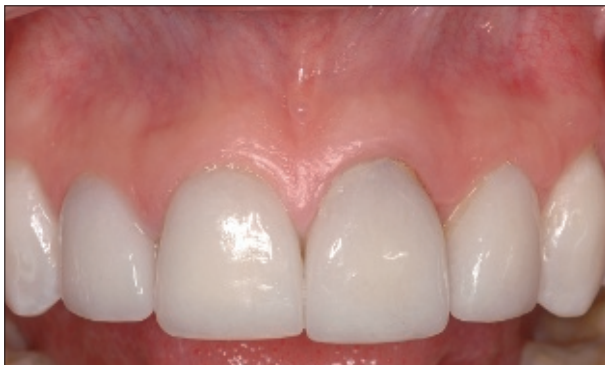
Fig 2 Retracted view. Medium to thick soft-tissue phenotype with symmetrical gingival margins.

Anterior retracted view revealed a medium to thick tissue phenotype and closely symmetrical gingival margins. A slight discoloration was noted at the cervical margin of tooth 21 (Fig 2). A wide band of attached gingiva was observed along the existing ceramic veneers on teeth 12 to 22.

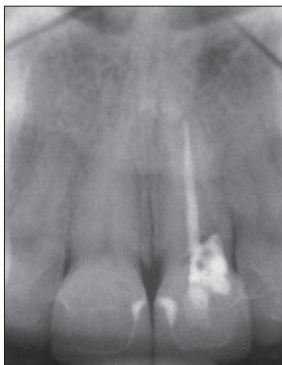
Fig 3 Periapical radiograph. Internal resorption defect coronally and result of previous endodontic treatment.

The initial periapical radiograph was suggestive of internal root resorption with possible extension to the external aspect on the distal of tooth 21 (Fig 3). Postorthodontic root blunting was visible on teeth 12 and 22.

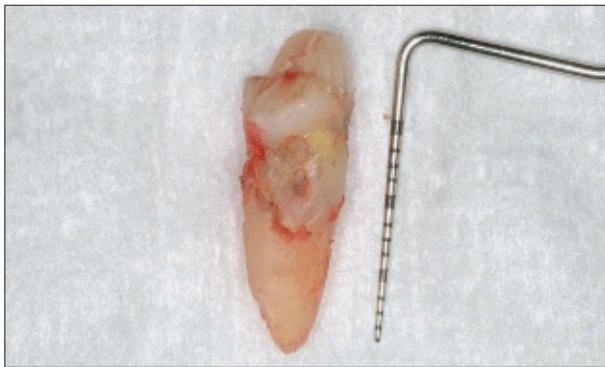
Fig 5 At the time of extraction, the extent of the perforation of the tooth root due to the internal resorption process became evident.

The tooth was carefully removed with a periosteal elevator without damaging the alveolar housing. Upon examination of the tooth, external root resorption was noticed on the distopalatal aspect of tooth 21. There was a concomitant probing depth at the location of the resorption, but it did not result in any significant bone loss that would have prevented treatment (Fig 5).

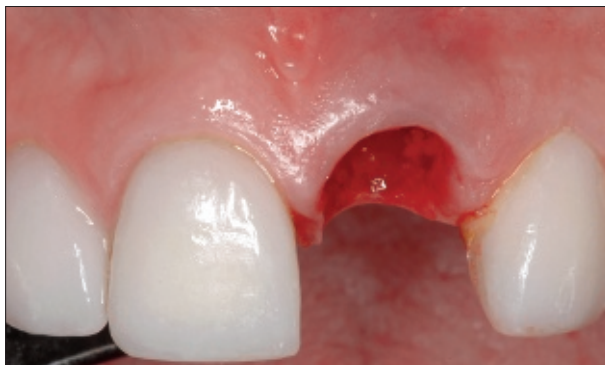
Figures 6 and 7 show the site following minimally traumatic extraction of tooth 21 (Figs 6 and 7). There was no incision, tissue trauma, or displacement following the extraction.

Figs 6 and 7 Soft-tissue contours following tooth removal and occlusal view of the socket following tooth removal.

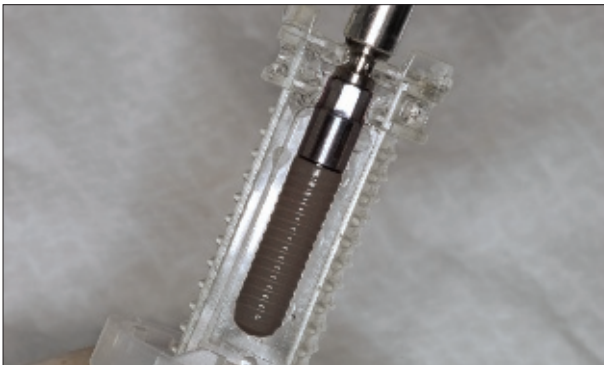
Fig 10 A Bone Level Regular CrossFit implant (diameter 4.1 mm, length 14 mm).

A Bone Level implant (diameter 4.1 mm, length 14 mm; Institut Straumann AG, Basel, Switzerland) (Fig 10) was placed in the correct three-dimensional position as planned, with the implant shoulder positioned 3 mm away from the planned mucosal margin of the implant-supported restoration (Figs 11 and 12).

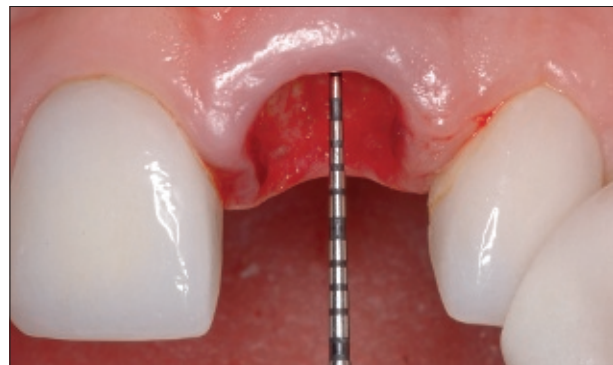
Fig 12 The periodontal probe is placed at the implant shoulder to demonstrate its position 3 mm apical of the proposed gingival margin.

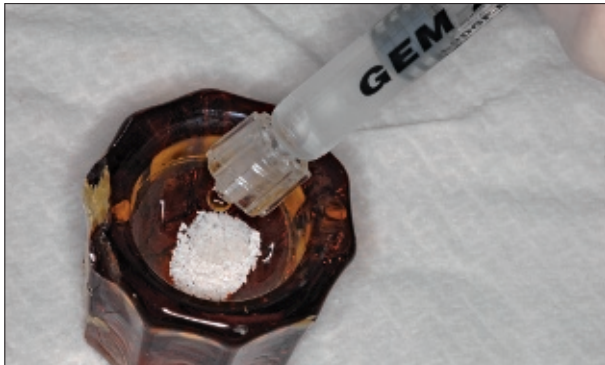
Fig 14 Bovine-derived xenograft being hydrated with recombinant human PDGF.

The horizontal dimension of the defect was grafted using a xenograft derived from bovine hydroxyapatite (Bio-Oss; Geistlich Pharma, Wolhusen, Switzerland) hydrated with recombinant human platelet-derived growth factor (rhPDGF) (Gem21; Osteohealth, Shirley, NY, USA) (Fig 14).

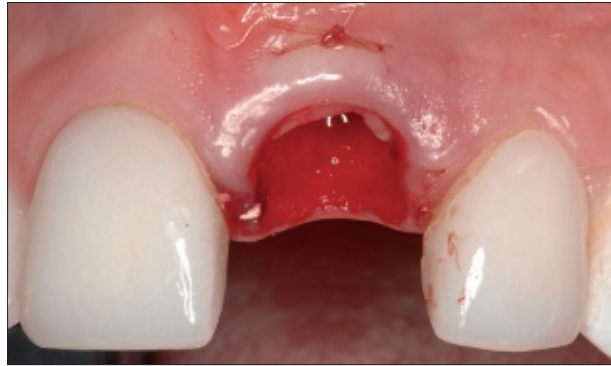
Fig 17 Facial view of the horizontal mattress suture securing the connective-tissue graft to the facial wall of the socket.

A single 5-0 chromic gut horizontal mattress suture (Ethicon; Somerville, NJ, USA) was used to secure the soft-tissue graft (Fig 17). Finally, a customizable Regular CrossFit (RC) polymer healing cap (Institut Straumann AG) was placed for the patient to wear while in transit to her prosthodontist's office for fabrication of the immediate provisional (Fig 18). The postoperative radiograph confirmed the ideal positioning of the dental implant, away from the adjacent roots and any vital structures. (Fig 19).

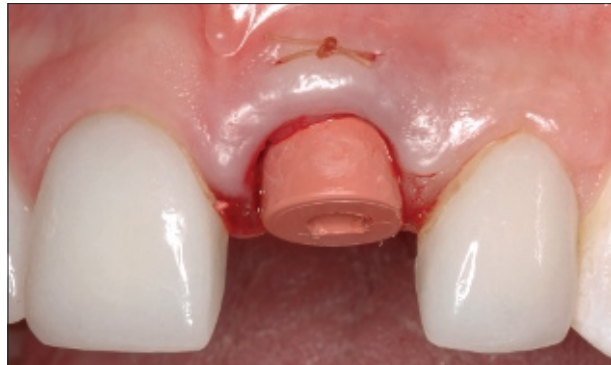
Fig 18 Customized Regular CrossFit polymer healing cap in position.

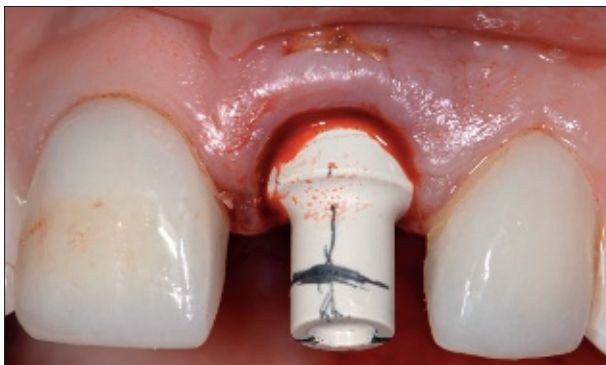
Fig 20 Regular CrossFit temporary abutment in place with reduction marks to guide customization.

When the patient had arrived at the prosthodontist's office, provisionalization began by removing the healing cap, placing a RC temporary abutment (RC PEEK abutment), and making marks to guide the reduction of the abutment (Fig 20).

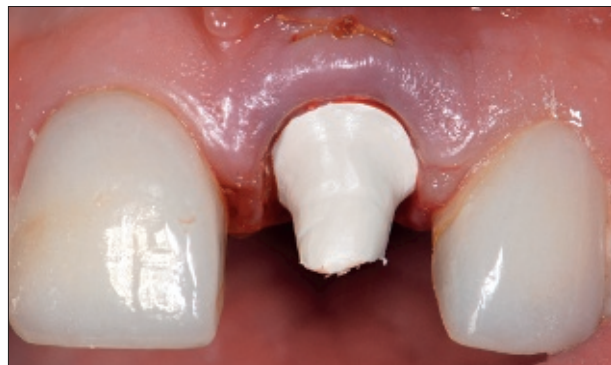
Fig 21 Provisional abutment preparation.

The provisional abutment preparation was then completed (Fig 21). The finish lines were located just below the mucosal margin to facilitate access to the cement line for clean-up.

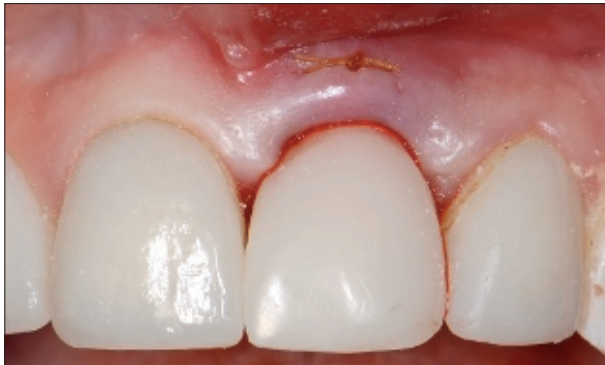
Fig 23 The completed provisional restoration.

The completed provisional (Fig 23) exhibited ideal contours, allowing for ideal prosthetic volume for the restorative materials and papillae to fill in during healing and maturation. The occlusion was carefully checked to ensure that no contact could occur during excursive or functional movements (Fig 24).

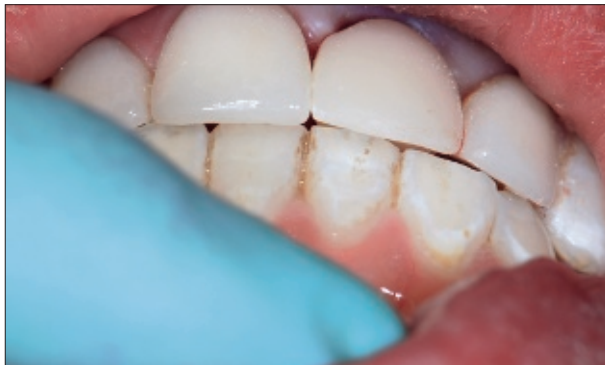
Fig 24 Occlusion check of the provisional restoration.

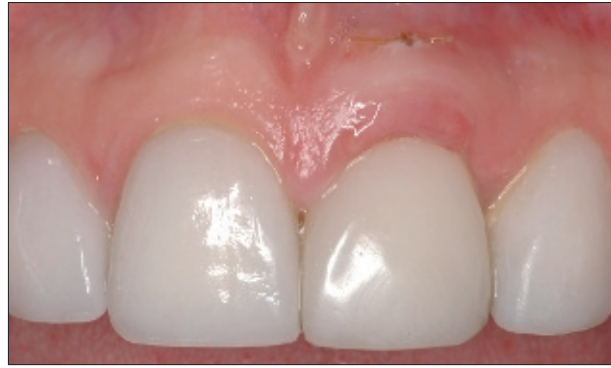
The two-week follow-up photograph illustrates an uneventful healing response, with tissue rapidly filling the papillary areas (Fig 25).

Fig 25 At two weeks. Excellent adaptation of the soft tissue.

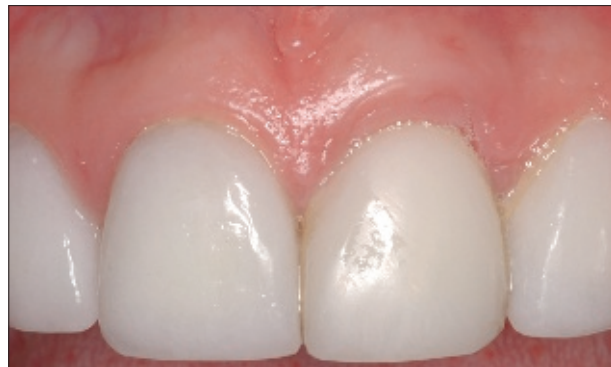
Fig 26 At two months.

At two months, the peri-implant tissues were maturing nicely, maintaining the desired mucosal margin position (Fig 26). However, a distinct demarcation between the native tissue and the connective-tissue graft began to emerge.

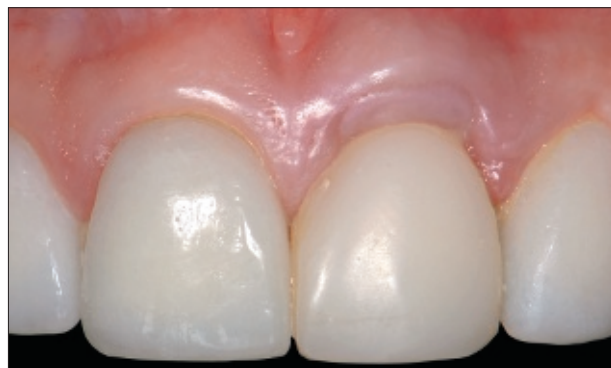
At five months, although the tissue volume was ideal and the gingival margins were stable, this demarcation was even more prominent. Plans were made to perform dermabrasion to smooth the tissue contours (Fig 27). A follow-up radiograph was taken at this time to verify stable bone levels around the implant (Fig 28).

Fig 27 At five months. The tissue had matured and facilitated the start of final restorative process.

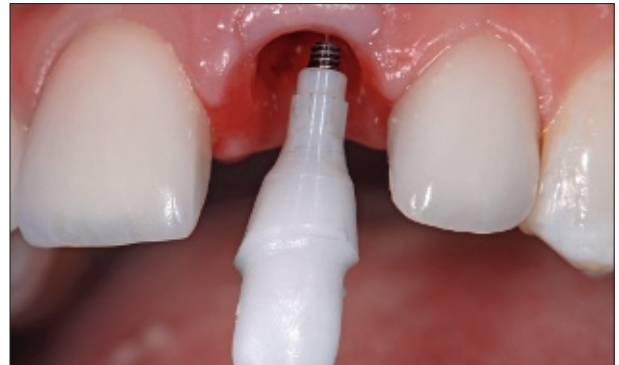
Fig 32 Custom zirconium abutment prior to seating.

A RC CAD/CAM customized zirconia abutment (CARES) (Institut Straumann AG) was fabricated and delivered prior to cementation of the final crown (Fig 32).

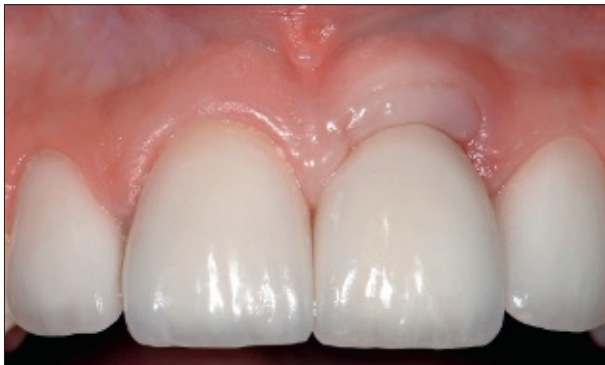
Fig 33 Final restorations in place on the day of delivery.

Figure 33 shows the patient's final restorations on the day of delivery. The uneven tissue contact areas were recontoured with a fine diamond bur under copious irrigation.

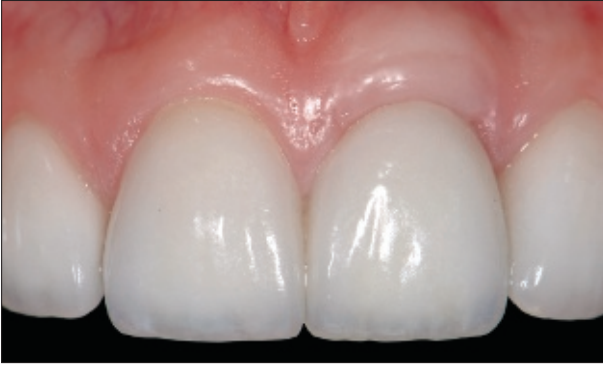
Fig 34 One year after treatment.

The photograph taken at one year post-treatment demonstrated stable and symmetrical tissue contours (Fig 34).

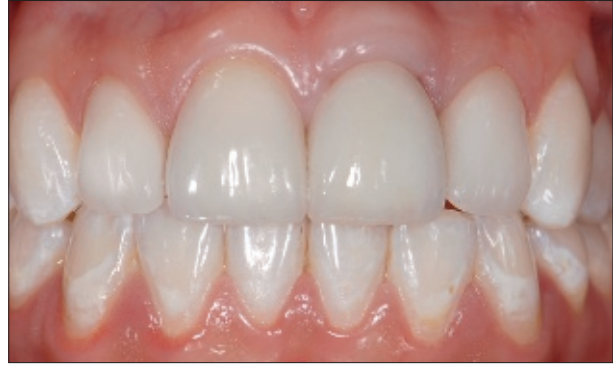
Fig 35 Retracted anterior view at one year.

The anterior retracted view at the same visit again showed excellent results, with harmonious tissue contours that were free of inflammation or other complications (Fig 35).

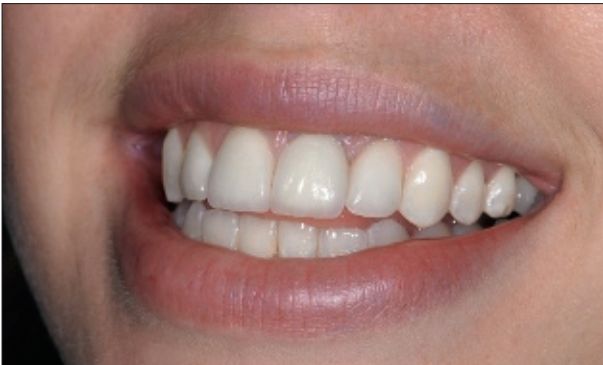
Fig 36 The patient's smile at one year.

The one-year photo of the patient's smile illustrated the patient's satisfaction with the final esthetic result (Fig 36).
