6.7 Early Implant Placement, Contour Augmentation, and Autologous Connective-Tissue Graft Using a Tunneling Technique to Replace an Upper Incisor with Generalized Gingival Recession

E. Lorenzana, J. Gillespie

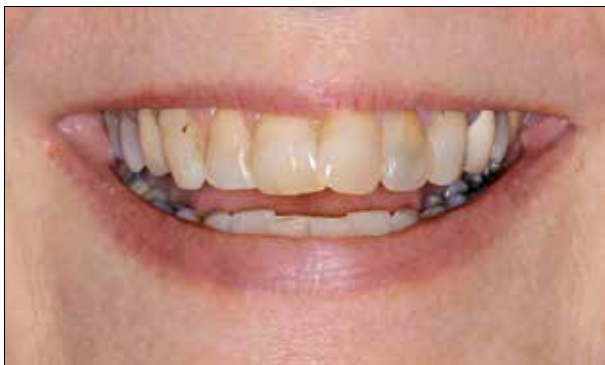
Fig 1 Medium lip line when smiling, exposing the papillae throughout the anterior sextant. Upper lip obscuring the gingival margins of the central incisors.

Analysis of her smile revealed a medium, symmetrical smile line, with only the interdental papillae visible at full smile. In addition, mild crowding was evident, with tooth 21 slightly overlapping tooth 11. The patient expressed no interest in orthodontic therapy. Tooth 22 was discolored and slightly displaced following its fracture (Fig 1).

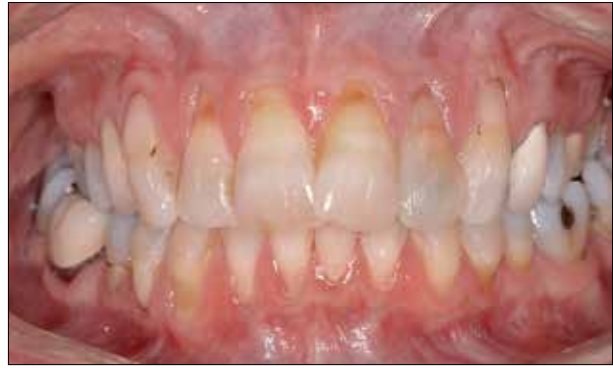
Fig 2 Retracted view. Thin gingival phenotype with generalized maxillary and mandibular gingival recessions.

The anterior retracted view revealed a thin gingival phenotype with triangular-shaped teeth and elongated papillae (Fig 2). Discoloration of tooth 22 was evident, together with a thin band of attached gingiva bordering the multiple gingival recessions affecting teeth 13 to 23. Teeth 13, 22, and 23 had class V bonded composite restorations, where the recessions measured from 3 to 5 mm across the maxillary and mandibular sextants.

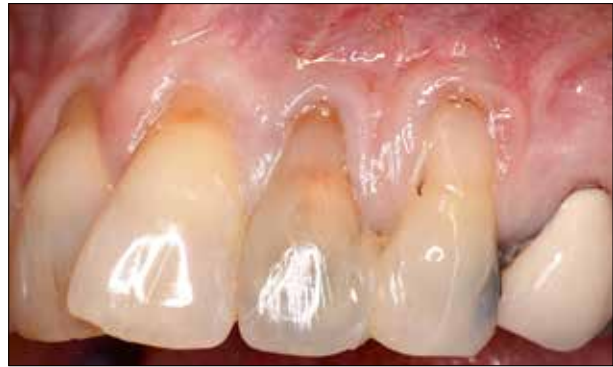
Fig 3 Focused view. Fractured tooth 22 showing discoloration of the tooth, 4.5 mm of recession and a class V composite restoration.

A focused view of tooth 22 more clearly illustrated the lack of soft tissue on the buccal aspect and the continued retraction of the gingival margin past the margin of the class V restoration (Fig 3). Such an observation indicates ongoing recession. In an intact dentition, this situation should be treated by augmenting the gingival volume and addressing the factors contributing to the progression of the recession, including occlusal trauma, destructive hygiene habits, or inadequate restorative interventions.

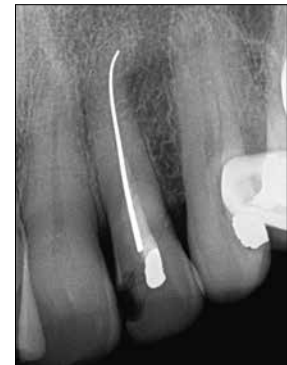
Fig 4 Periapical radiograph. Fracture extent and previous endodontic treatment with a silver-point filling and apical root curvature.

The initial periapical radiograph of tooth 22 revealed a silver-point endodontic restoration within a long root and a clearly visible fracture line. In addition, the root of tooth 22 was not centered within the proposed implant site, being instead close to tooth 12. Finally, a distal curve at the apical end of the root was visible, indicating a potentially complicated extraction (Fig 4).

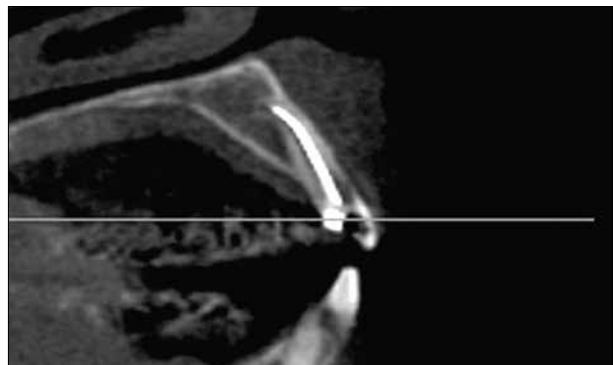
Fig 5 CBCT image. Adequate bone available apically to secure the fixture but with 50% buccal bone loss.

The patient was referred for a preoperative cone-beam computed tomography (CBCT) that demonstrated an adequate base of bone apical and palatal to the root apex to allow engagement of the native alveolar bone by the implant following the extraction of the tooth (Fig 5). However, the buccal bone plate was not visible until approximately midway down the root, corroborating the advanced gingival recession observed clinically. Finally, the CBCT indicated possible internal root resorption of tooth 22.

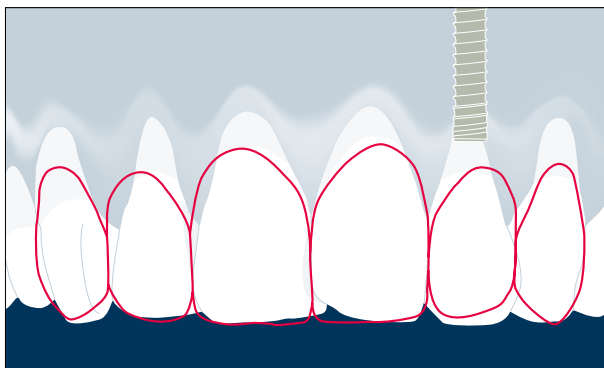
Fig 7 Crown dimension outlines. Desired outcome following treatment. Implant shoulder was positioned 3 to 3.5 mm apical to the desired gingival margin.

Fig 7 illustrates the desired treatment outcome by outlining the ideal gingival margin positions of teeth 13 to 23. By establishing the goal of a more ideal, coronally positioned augmented gingival margin, the desired three-dimensional implant position 3 to 3.5 mm apical to the desired new gingival margin can then be determined.

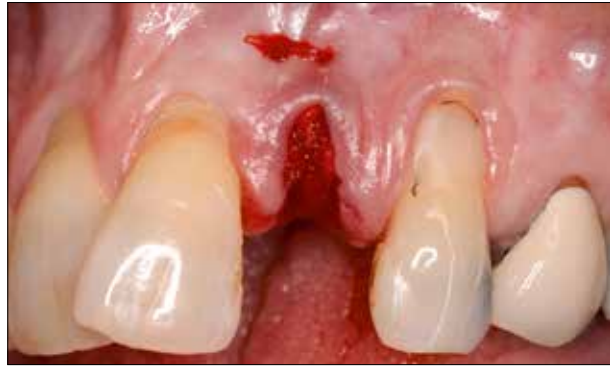
Fig 8 Tooth 22 removed with collagen plug in place.

Tooth 22 was removed using minimally traumatic techniques to preserve the soft tissue and surrounding alveolar bone (Fig 8). Briefly, a powered periosteal elevator (Powertome 100S, Westport Medical), was utilized to separate the tooth from the alveolus, then the tooth was delivered with traditional forceps. Following atraumatic extraction of the tooth, a collagen plug was placed within the socket and secured with a 5-0 chromic gut suture (Ethicon, Somerville, NJ, USA). No incisions and no tissue trauma or displacement were present following extraction. The root was sectioned from tooth 22 and the crown was bonded to the adjacent teeth as a provisional restoration during the healing phase.

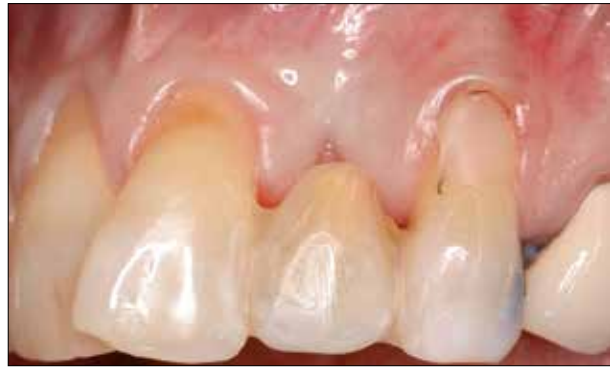
Fig 9 Healing of site 22 with bonded provisional in place at four months.

Six weeks after the extraction, the soft tissues at site 22 were completely healed and healthy, with most of the previously observed recession defect resolved. The patient was at this point deemed ready to proceed with implant placement, GBR, and soft-tissue augmentation (Fig 9).

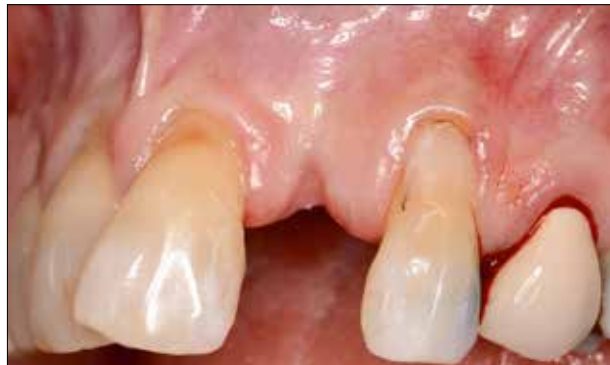
Fig 10 Site 22 prior to surgery. Complete epithelialization of site 22 at four months, ready for implant placement and GBR.

The bonded provisional restoration was removed to expose site 22 prior to surgery (Fig 10). The tissues were confirmed to be healthy, with a significant gain in volume that would allow for primary closure after the surgical procedure.

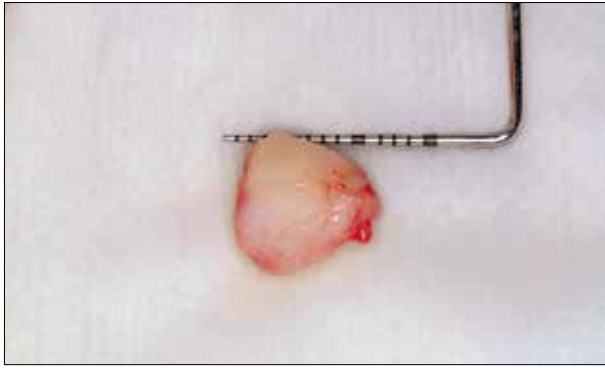
Fig 11 Soft tissue harvested from the tuberosity region distal to tooth 17.

Figures 11 and 12 show the tissue harvested from the tuberosity distal to tooth 27 followed by careful sectioning of the tissue to create ideal tissue-graft thickness of 1 to 1.5 mm.

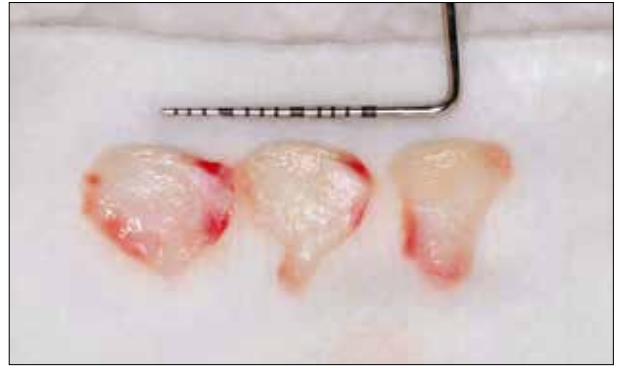
Fig 12 Tuberosity graft sectioned into three 1- to 1.5-mm sections.

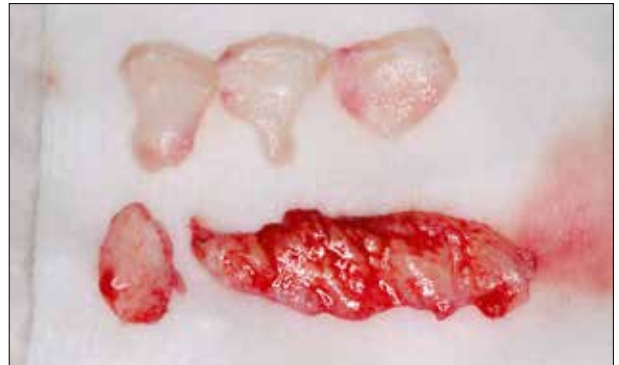
Fig 13 Additional soft tissue was harvested from the palate. All of the harvested soft tissue is shown.

Additional tissue was obtained from the left palatal vault through a single-incision technique (Lorenzana and Allen 2000). The total tissue harvested is shown in Fig 13.

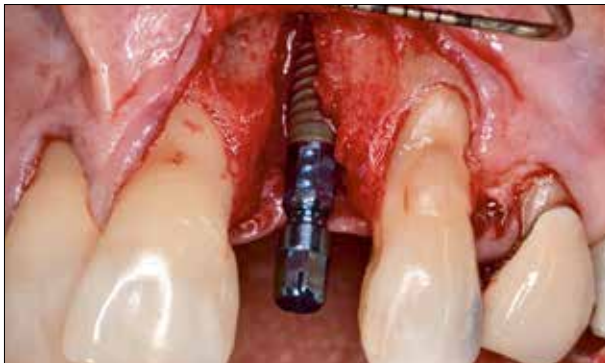
Fig 14 The selected implant in the corrected three-dimensional position before GBR and soft-tissue grafting.

Following reflection of a full-thickness flap, an implant (Bone Level Narrow CrossFit, diameter 3.3 mm, length 14 mm; Institut Straumann AG, Basel, Switzerland) was placed in the correct three-dimensional position as planned, with the implant shoulder positioned 3 mm away from the gingival margin (Figs 14 and 15).

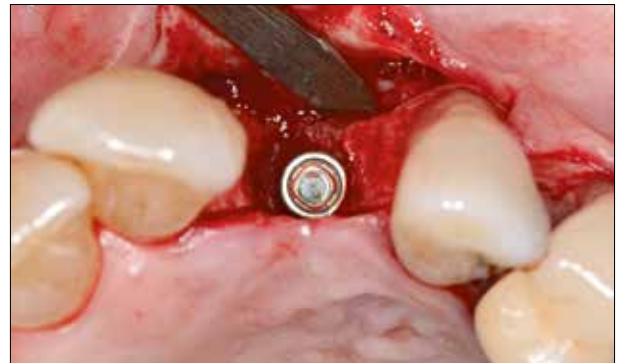
Fig 15 Occlusal view of implant 22 placed within the alveolar envelope, on the palatal aspect of the alveolar socket.

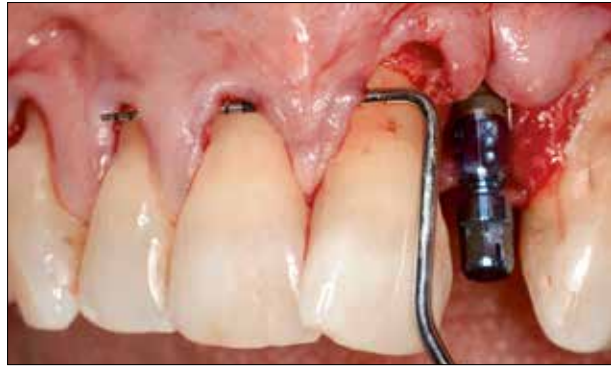
Fig 16 Completed tunnel preparation. Continuity verified with a periodontal probe within the tunnel.

Specialized tunneling instruments were employed to elevate the tissue (Allen End-Cutting Intrасulcular Knife, Allen Periosteal Elevator Anterior, and Allen Arrowhead Knife; Hu-Friedy, Chicago, IL, USA), creating a tunnel-bed preparation from tooth 13 to 21 (Fig 16). A periodontal probe was used to verify the continuity of the tunnel preparation.

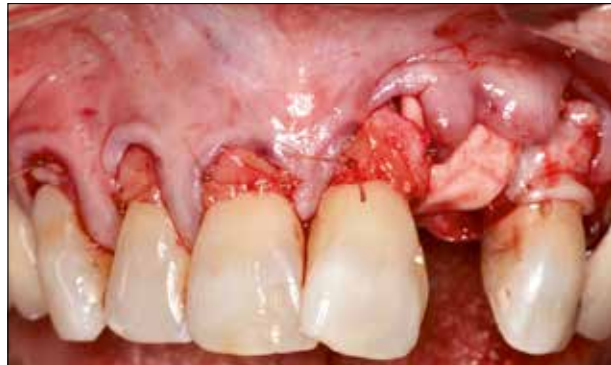
Fig 17 Completed GBR procedures. Soft-tissue grafts in place.

The larger connective-tissue graft was carefully guided into the tunnel and secured with circumferential 5-0 chromic gut sutures over teeth 13 to 21 (Fig 17). Additional soft tissue was secured over tooth 23 in a similar manner. GBR was then performed over implant 22 in the manner reported by Buser and coworkers (2008), with autologous bone chips placed over the implant followed by xenograft derived from deproteinized bovine bone mineral (Bio-Oss; Geistlich, Wolhusen, Switzerland). Finally, a dual layer of non-crosslinked collagen membrane (Bio-Gide; Geistlich) was applied over the bone grafts.

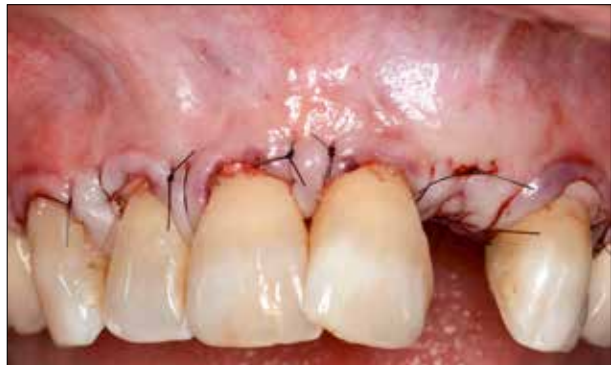
Fig 18 Completed closure of the surgical site.

Flap closure was accomplished with 6-0 monofilament nylon suture (Ethilon; Ethicon) applied as sling sutures over the soft-tissue grafting sites, and horizontal mattress and interrupted sutures over the GBR site (Fig 18). With the extra soft tissue created following removal of tooth 22 during the early healing phase, tension-free primary closure was more easily achieved.

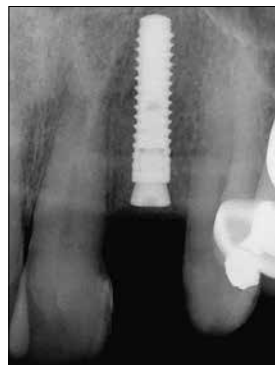
Fig 19 Radiograph taken immediately at the end of the procedure, confirming the implant position.

The postoperative radiograph confirmed the ideal position of the dental implant, away from the adjacent roots and any vital structures (Fig 19).

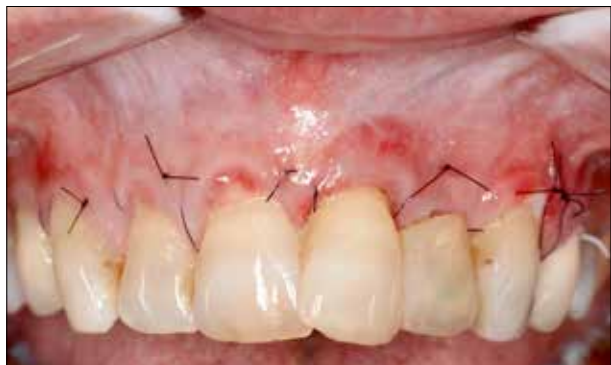
Fig 20 Two-week postoperative situation. Excellent healing and adaptation of the soft tissues.

The two-week follow-up photograph illustrates uneventful healing, with complete root coverage already evident at the soft-tissue grafting sites (Fig 20). A bonded provisional restoration was once more employed during the healing phase.

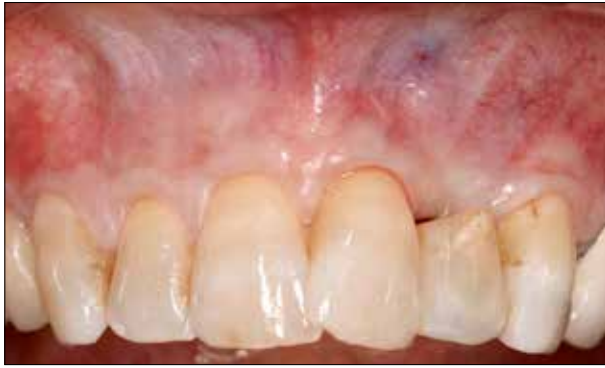
Fig 21 Four-month situation. Tissue maturation prior to uncovering.

At four months, the soft tissues had matured and the implant was ready for uncovering (Fig 21). Although an adequate band of keratinized mucosa was already present, uncovering of the implant provides an additional opportunity to create additional soft-tissue volume on the buccal aspect of the implant in preparation for provisionalization and tissue shaping.

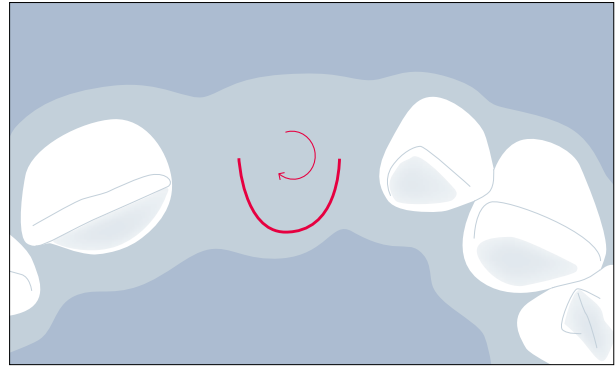
Fig 22 Incision design for uncovering.

A U-shaped incision design was used over the implant to create a pedicle of soft tissue that can be displaced facially (Barone and coworkers 1999; Mühlemann and coworkers 2012). This pedicle graft was then displaced facially into a shallow pouch that was then secured with a healing cap and sutures (Fig 22).

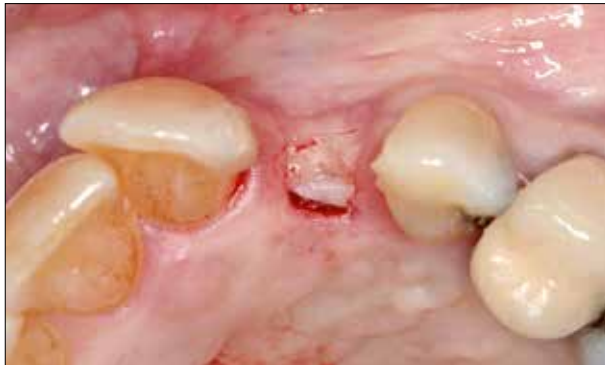
Fig 23 Tissue directly over the implant, de-epithelialized and with the incision completed.

The occlusal view of the implant site illustrates the need for additional buccal soft-tissue volume (Fig 23). First, the U-shaped incision was made and the overlying tissue de-epithelialized using a fine No. 8 diamond round bur (Brasseler, Savannah, GA, USA).

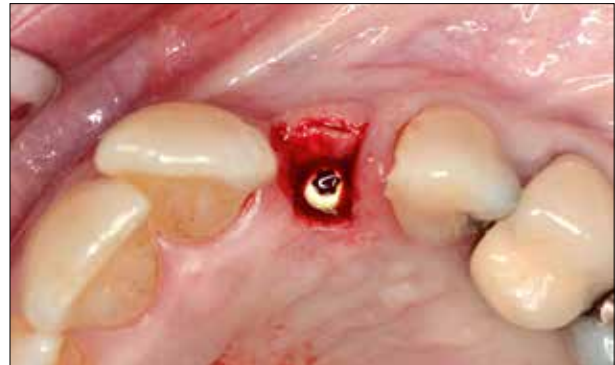
Fig 24 Tissue pedicle rotated buccally, exposing the cover screw.

The tissue was elevated with an Orban knife, exposing the healing abutment (diameter 3.6 mm, height 2 mm) (Fig 24). The tissue was carefully tucked into the buccal aspect with a tunneling instrument (Allen Periosteal Elevator Anterior; Hu-Friedy).

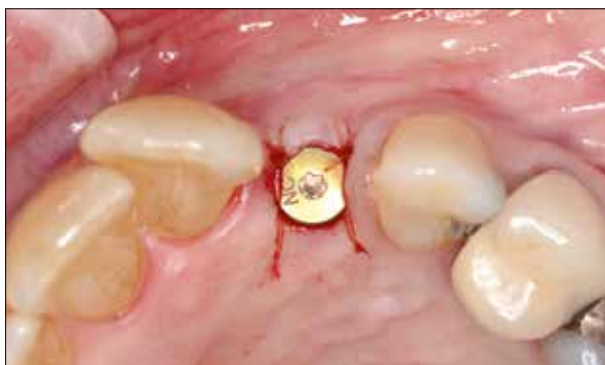
Fig 25 Uncovering completed with a larger healing abutment in place and sutures to secure the flap.

The original healing cap was replaced with another healing abutment (diameter 4.8 mm, height 5 mm) to help position the rotated pedicle flap (Fig 25). Additional 5-0 chromic gut sutures were applied to further secure the area.

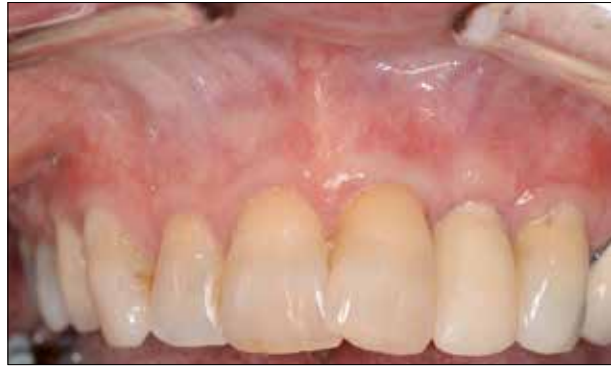
Fig 26 Provisional restoration in place.

A provisional restoration was fabricated and delivered to initiate shaping of the peri-implant tissues (Fig 26). A follow-up radiograph was also taken at this time to verify stable bone levels around the implant (Fig 27).

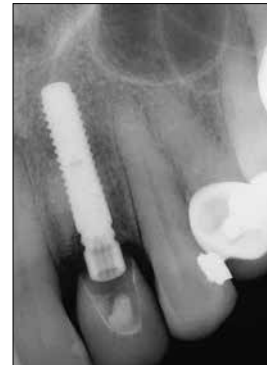
Fig 27 Follow-up radiograph with provisional in place documenting healing of the fixture.

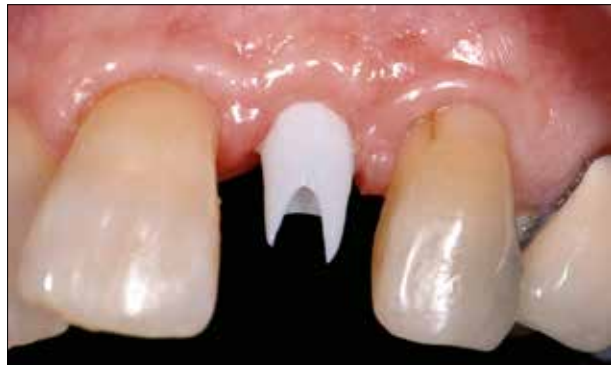
Fig 28 The customized CARES abutment in situ.

A digital impression was taken. A customized zirconia abutment was designed and fabricated using CARES (Straumann). The abutment was torqued to 35 Ncm (Fig 28).

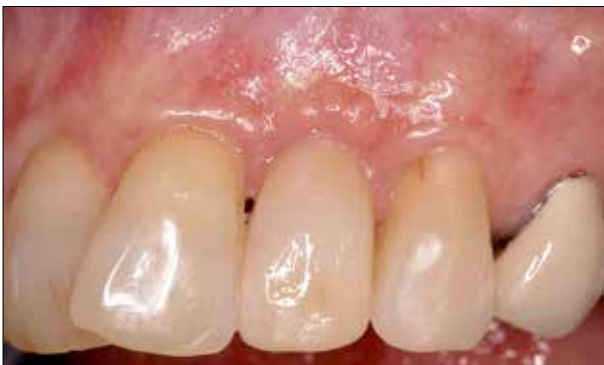
Fig 29 Final restoration after cementation.

A custom stained and glazed lithium disilicate crown was fabricated and cemented using a radiopaque luting agent (IPS e.max; Ivoclar Vivadent, Schaan, Liechtenstein; and MaxCem; Kerr Dental, Orange, USA). Figure 29 shows the final restoration on the day of delivery.

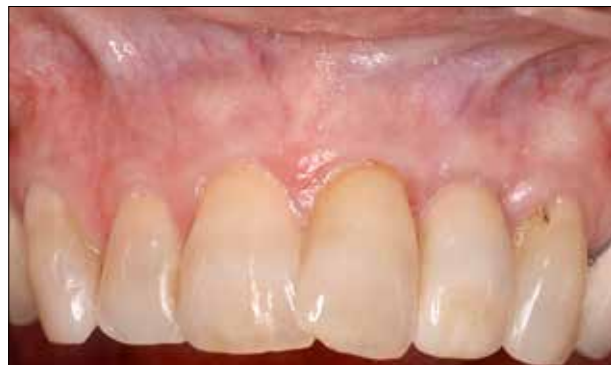
Fig 30 Retracted anterior view at three years. Well-maintained soft-tissue profile.

The photograph taken at the three-year follow-up demonstrated stable, symmetric tissue contours, with gingival margins free of inflammation or other complications (Fig 30).

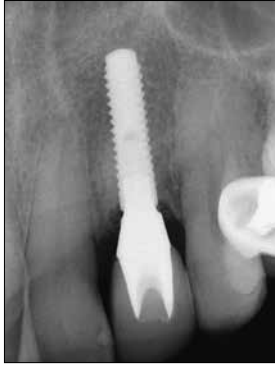
Fig 31 Radiograph at three years. Well-maintained bone levels.

The three-year periapical radiograph documented that the emergence profile of the final restoration was in harmony with the bone profile at the implant site and continued stable bone levels were evident along the entire length of the implant, especially around the implant shoulder (Fig 31).

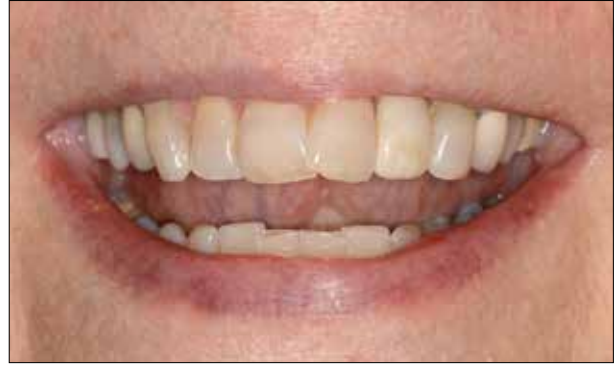
Fig 32 Full smile three years after delivery. Stable and pleasing esthetic result.

The patient's smile at the three-year follow-up visit clearly illustrated her satisfaction with the esthetic result (Fig 32).
